Truck Driver Killed When Front-End Loader Secured by Chains on a Lowboy Trailer Broke Free and Rolled Onto Cab

SUMMARY

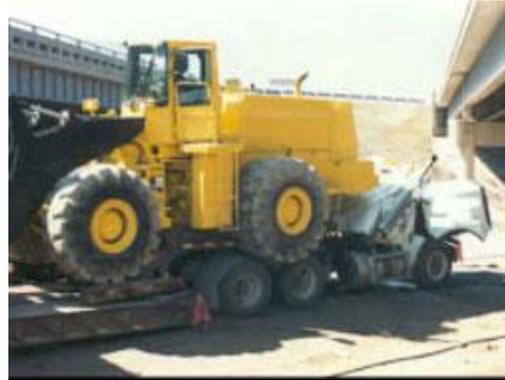
On April 10, 2002, a 56-year old truck driver with 22 years of experience died when a front-end loader weighing between 60,000 and 65,000 pounds that was being transported on a 50-ton lowboy trailer broke free from its securing chains and rolled onto the cab crushing him. The loader transmission was in neutral and the parking brake was set. The victim used at least four 3/8-inch chains rated at 6,600 pounds (the exact number is unknown) to secure the loader. Five binders were found at the scene. One chain appeared to be improperly attached to the loader's maintenance ladder, one chain appeared to be attached to an attachment point on the loader. The remaining chain attachments to the loader are unknown. If four chains were used, the load exceeded the aggregate working load limit of the chains. Also unknown is where each of the chain hooks and/or binder hooks were attached to the trailer. Based on the police report of the incident, at least one chain hook/binder was improperly attached to the trailer bed. One chain appeared to have an oversized hook. During transport, the driver stopped suddenly between two bridges. Skid marks from the truck were present on the roadway. It appears that a sudden stop caused sufficient force on the chains to break them. The loader rolled forward over the 5th wheel and onto the top of the truck cab. The cab was crushed, and the driver was declared dead at the scene.

Figure 1. Loader on truck cab

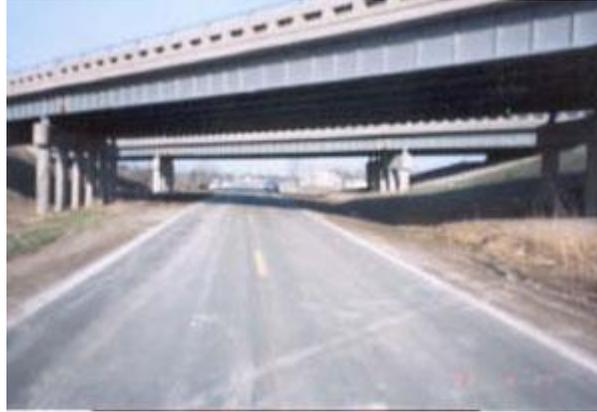
The loader was transported on a 2-lane paved, flat roadway that was in good condition. The speed limit was 55 mph. On the day of the incident the investigating police could not detect an obstacle that could have impaired the driver's vision. The overpass was measured at 17 feet 2 inches above the ground; the height of the truck with its load was 14 feet 1 inch.

Figure 2. Road where incident took place

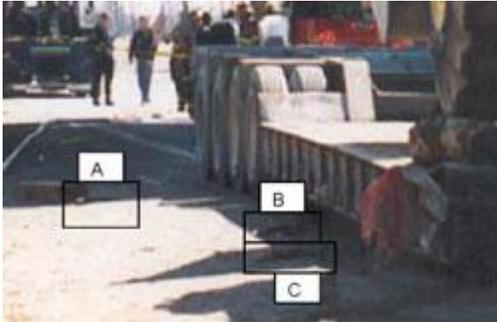
Police noted several chains and binders on the ground on each side of the trailer. The police located three ratchet binders and one chain on the passenger side of the truck's trailer. [Figure 3](#) shows the chain and binder locations on the passenger side. One binder with a broken hook was found at the rear of the trailer (Box A). One binder/chain with a broken chain link were found at the middle of the trailer (Box B). One binder was located at the front of the trailer (Box C). [Figures 4-5](#) show a close-up view of the binder with the broken hook noted in [Figure 3](#), Box A.

Figure 3. Passenger side, Binders and chains marked in Boxes A-C

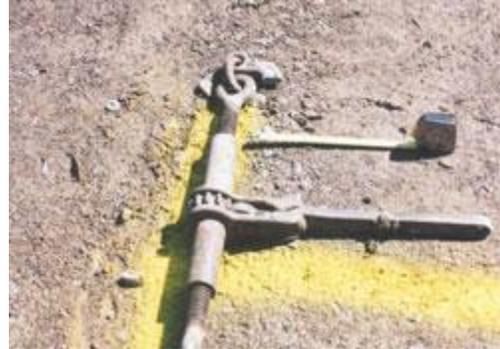
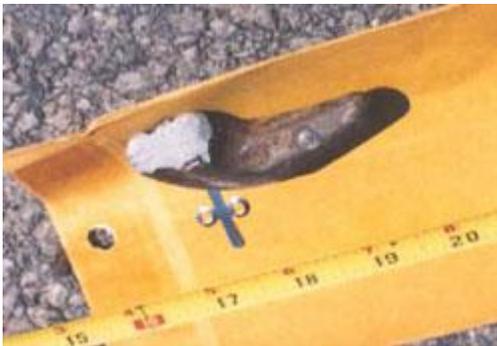
Figure 4. Broken binder hook, passenger side

Figure 5. Broken hook, passenger side

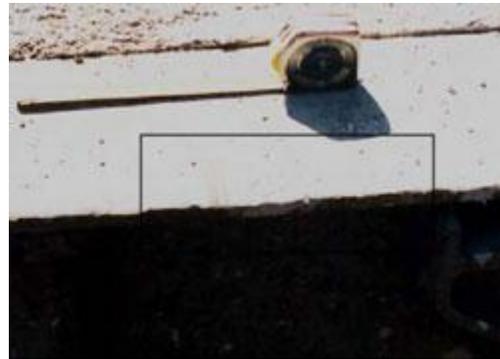
During their investigation, police found fresh scratches on the middle of the trailer decking. There were no fresh marks or scratches on the "D" rings. The box in [Figure 6](#) outlines the chain or binder marks.

Figure 6. Chain or binder marks on trailer

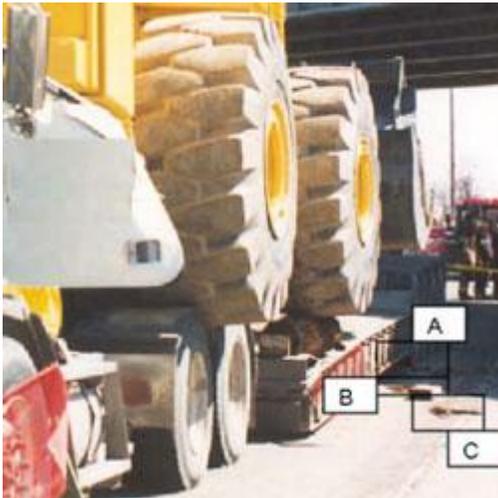
On the driver's side of the vehicle, [Figure 7](#) shows the chains and binders found on the ground. One long chain was found at the rear of the trailer. (Box A and [Figure 8](#)) Another chain and binder were located at the middle of the trailer (Box B, and [Figure 9](#)). A binder was found toward the front of the trailer (Box C).

Figure 7. Driver's side view of chains and binders. Binders and chains marked in Boxes A-C

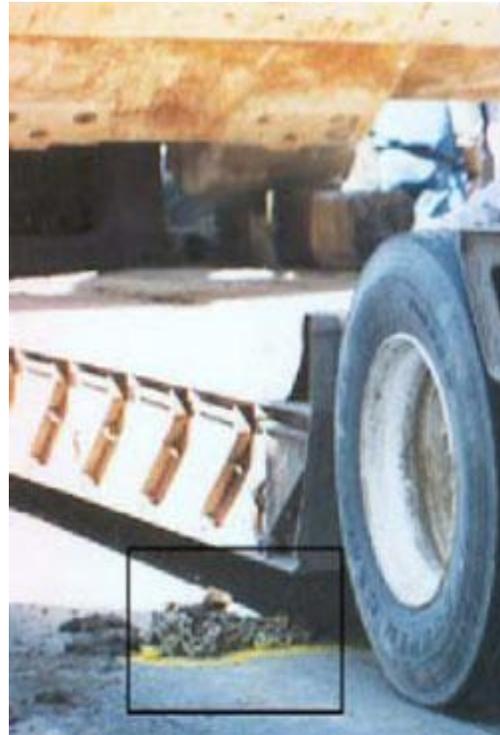
Figure 8. Long chain at trailer rear on driver's side

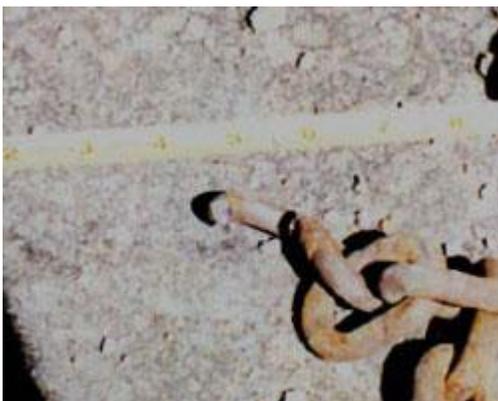
Figure 9. Broken chain, middle of trailer, driver's side

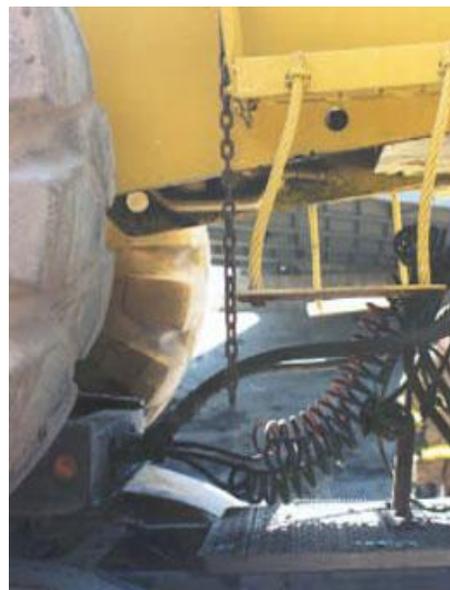
Broken chains were also attached to the loader. One chain appeared to be attached to the mechanic's ladder (See [Figure 10](#)) on the passenger side of the truck. Two chains were attached to the loader bucket ([Figure 11](#)). It is unknown if the chains on the bucket were used for securing the loader or if they were used earlier and prior and were not taken off the loader prior to transport. One chain is attached to an attachment point on the loader (See [Figure 12](#)).

Figure 10. Chain on mechanic's ladder, passenger side.

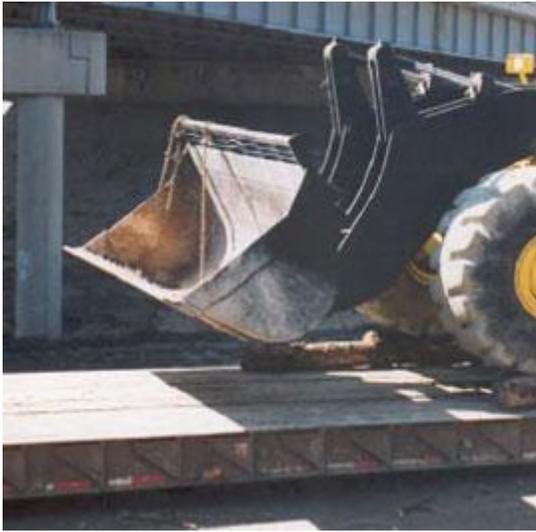
Figure 11. Two chains on loader's bucket

The victim did ensure that the loader's hydraulic bucket (accessory equipment) was completely lowered to the trailer bed. It is unknown if the chains on the bucket were intended to secure the bucket to the trailer and to prevent articulation in transit.

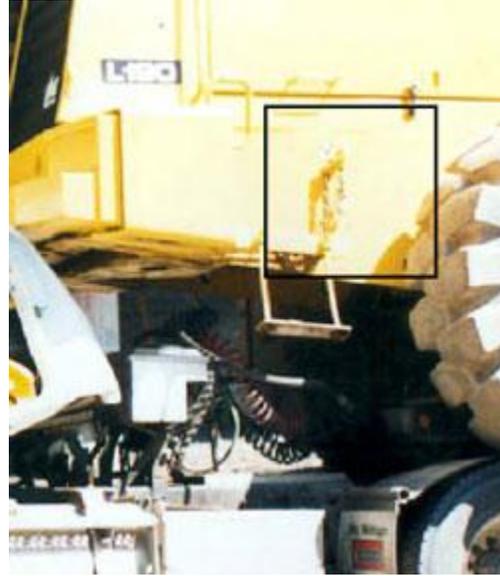
Figure 12. Chain located on loader, driver's side

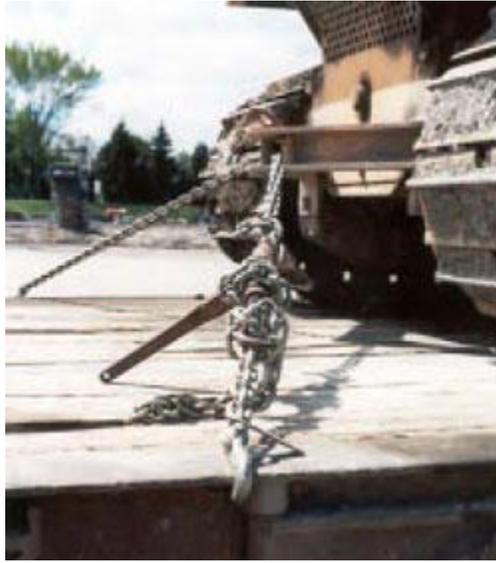
During the MIFACE visit, the company representative arranged for a lowboy trailer that was loaded with a piece of heavy machinery to be driven to the company headquarters so the MIFACE representative could see how a load should be secured. The loader blade was retracted and wedged against the trailer end. The individual who secured the load on the trailer stated he was trained by the victim and also by a trade association representative on proper load securement procedures. [Figures 13](#) and [14](#) show that the loader was not properly secured on the trailer bed. [Figures 13](#) and [14](#) were taken looking down the driver's side of the trailer. [Figure 13](#) shows that one of the chains used to secure the load is improperly attached to the trailer bed. [Figure 14](#) shows proper attachment to the "D" ring, but improper loader attachment.

Figure 13. Improper attachment of loader to trailer bed

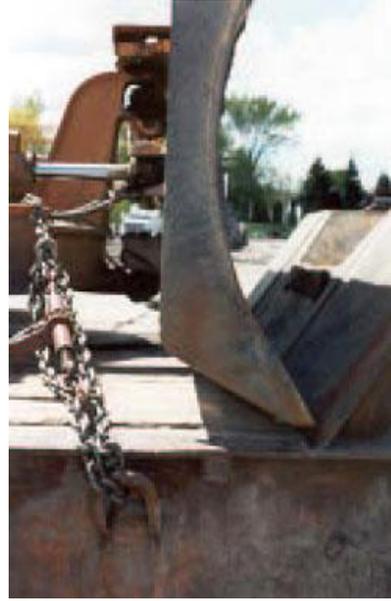
Figure 14. Proper attachment to "D" ring

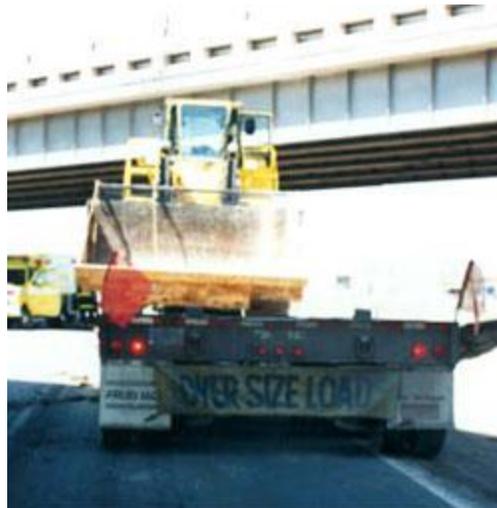
The load was not adequately secured against longitudinal (forward/rearward) and lateral movement. See [Figure 15](#). Protecting against longitudinal movement insures the cargo remains on the vehicle and does not penetrates the vehicle's front-end structure. Protection against lateral movement insures the load does not shift sideways in transit.

Figure 15. Lateral movement of loader

To properly secure a load to the trailer, the tiedown assemblies must be properly attached to the load itself, as well as to the “D” rings on the trailer. If it is unknown where on the load the tiedown assemblies should be attached, or if the piece of equipment does not have readily identifiable attachment points for the tiedown assembly, companies should contact the manufacturer to obtain the manufacturer’s recommended attachment points.

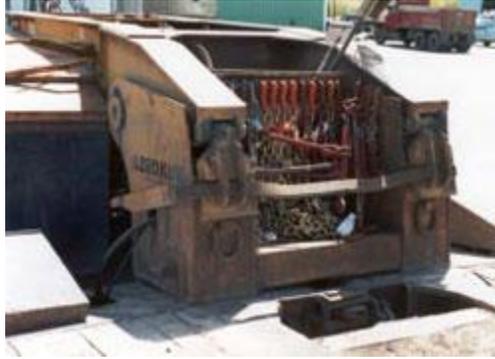
Company personnel indicated that the company has upgraded from 3/8-inch chains to 1/2-inch chains. See [Figure 16](#). The entire tiedown assembly is only as strong as its weakest component. When upgrading, the company must take the next necessary step to ensure that the chain upgrade does not exceed the working load limit of any of the other components of the assembly, such as the hooks, tensioner, “D” rings, equipment attachment points, etc.

Figure 16. Storage area holding ½ inch chains

- Companies should ensure that consistency is maintained with the working load limits of all components of a tiedown assembly.

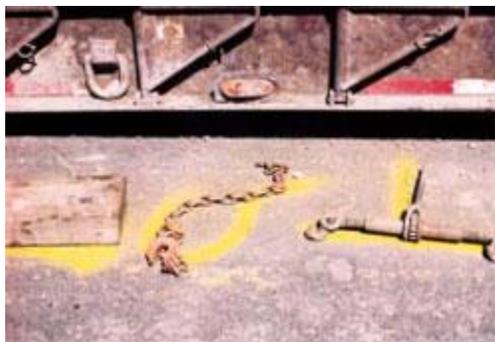
On the day of the incident, it appears that the victim used a grab hook with a throat too big for the 3/8-inch chain link. See [Figure 17](#). The chain links would not fit securely inside of the throat and could possibly slip during transport.

Figure 17. Oversized hook, driver's side

- Companies should ensure all components of a tiedown assembly are inspected for defects and correlate in size while securing each load.

FMCSA Rule 393.104 states that all vehicle structures, systems, parts, and components including vehicle tiedown anchor points used to secure cargo must be in proper working order when used to perform that function with no damaged or weakened components that will adversely effect their performance for cargo securement purposes, including reducing the working load limit and must not have any cracks or cuts. Company personnel indicated that they routinely check the chains for stretched links by laying the chain out and measuring. According to a company worker, chains normally don't stretch; they break. The workers do not routinely check for damaged chain links, damaged transport vehicle anchor points, or damage to the anchor points on the load. MIFACE recommends that the company require drivers who transport loads to check all components of the tiedown assembly during securement to ensure all components are in proper working order.
