California Forest Highway 177, Beckwourth to Clover Valley

INTRODUCTION

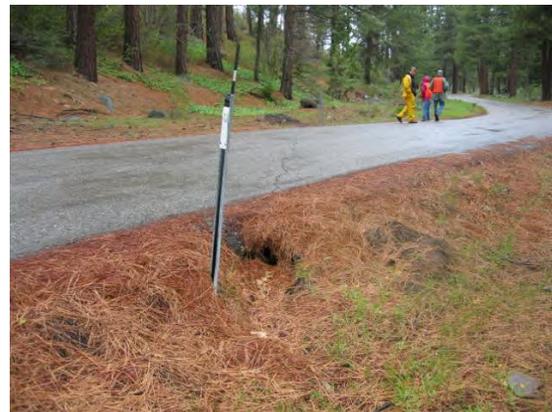
Figure 3. Narrow Roadway Pavement Cracking and Inadequate Drainage

The majority of the 9.6-mile stretch this project is evaluating is in degraded condition and does not meet current design standards. The roadway surface along much of the route is deteriorating and is most noticeable with extensive pavement cracking and rutting between MP 2.5 and 5.1(see Figure 3) and poor gravel surface between MP 5.1 and 9.6. The insufficient or outdated drainage along the route is exacerbating this problem. Numerous existing culverts along FH 177 are inadequate to accommodate runoff due to silting in of the inlets. The roadway varies in width from 16 to 28 feet and has numerous sharp curves (substandard roadway geometry); these are difficult conditions that make the roadway more challenging to drive. In several locations, the roadway is too narrow to safely accommodate two-way traffic, and the poor sight distances presents even greater safety concerns.

- Substandard sight distances and roadside hazards
- Poor surface drainage and erosion
- Substandard roadway geometry (sharp curves)
- Substandard stream crossing at Crocker Creek
- Poor pavement condition/gravel surface
- Insufficient roadway width
- Pedestrian hazard at the Ceresola Ranch
- Substandard intersection at MP 9.6

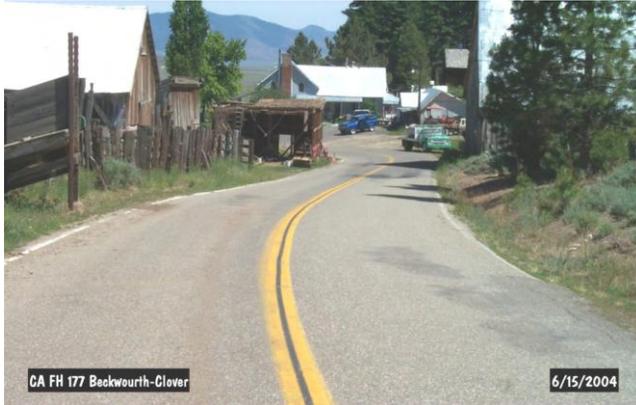
Figure 4. Structures Adjacent to FH 177 at Ceresola Ranch

From MP 1.8 to 2.5, the road traverses through a private ranch where several structures are located immediately adjacent to both sides of the road (see Figure 4). In addition to these structures, the road narrows and has two sharp turns through the ranch that contribute to poor sight distance and result in a hazard for vehicles traveling along FH 177 as well as pedestrians intent on crossing from the residences on the west of FH 177, to the ranch outbuildings located on the east side of FH 177. At MP 6.6 there is a narrow 15-foot wide structural concrete stream crossing, with a substandard 8-inch channel iron guard rail, that impedes the

Segment 2 (MP 1.7 to 2.5): This segment is a currently paved section of roadway that passes through the Ceresola Ranch with several structures located immediately adjacent to both sides of the road. There is currently no posted speed limit. The road narrows and has two sharp turns that contribute to poor visibility and pedestrian hazards. For this segment, it is proposed to realign the roadway away from the built ranch structures to the east in order to accommodate a roadway that meets current design standards. Several design variations were initially considered in this segment, and reasons for their dismissal are described below in Section 2.3. Avoidance and minimization efforts were also applied to reduce the impacts on environmental resources, whenever practicable.

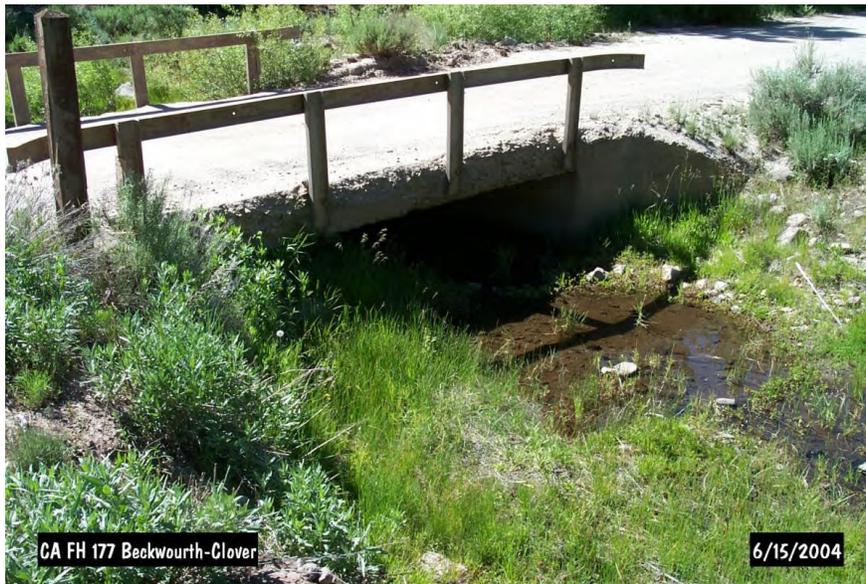
Figure 5. Substandard Structural Concrete Stream Crossing at Crocker Creek MP 6.6

flow of two-way traffic (see Figure 5). The small structure also impedes flow in Crocker Creek as the poor hydraulic performance under storm flow conditions does not meet current design requirements. The intersection at MP 9.6, the end terminus of the project, has inadequate sight distance and is inadequate for right angle turning movements (see Figure 6) (FHWA 2004).

Short-term closures of the road may occur at specific construction milestones, such as replacement of the Crocker Creek crossing. Advanced notification would be provided to the traveling public prior to any temporary closures. Emergency access would be maintained throughout construction. The proposed action includes all the road reconstruction and rehabilitation activities described above. Operation and maintenance of the road are the responsibility of Plumas County up until the end of the project, and then the PNF maintains the roadway past the end of the project.

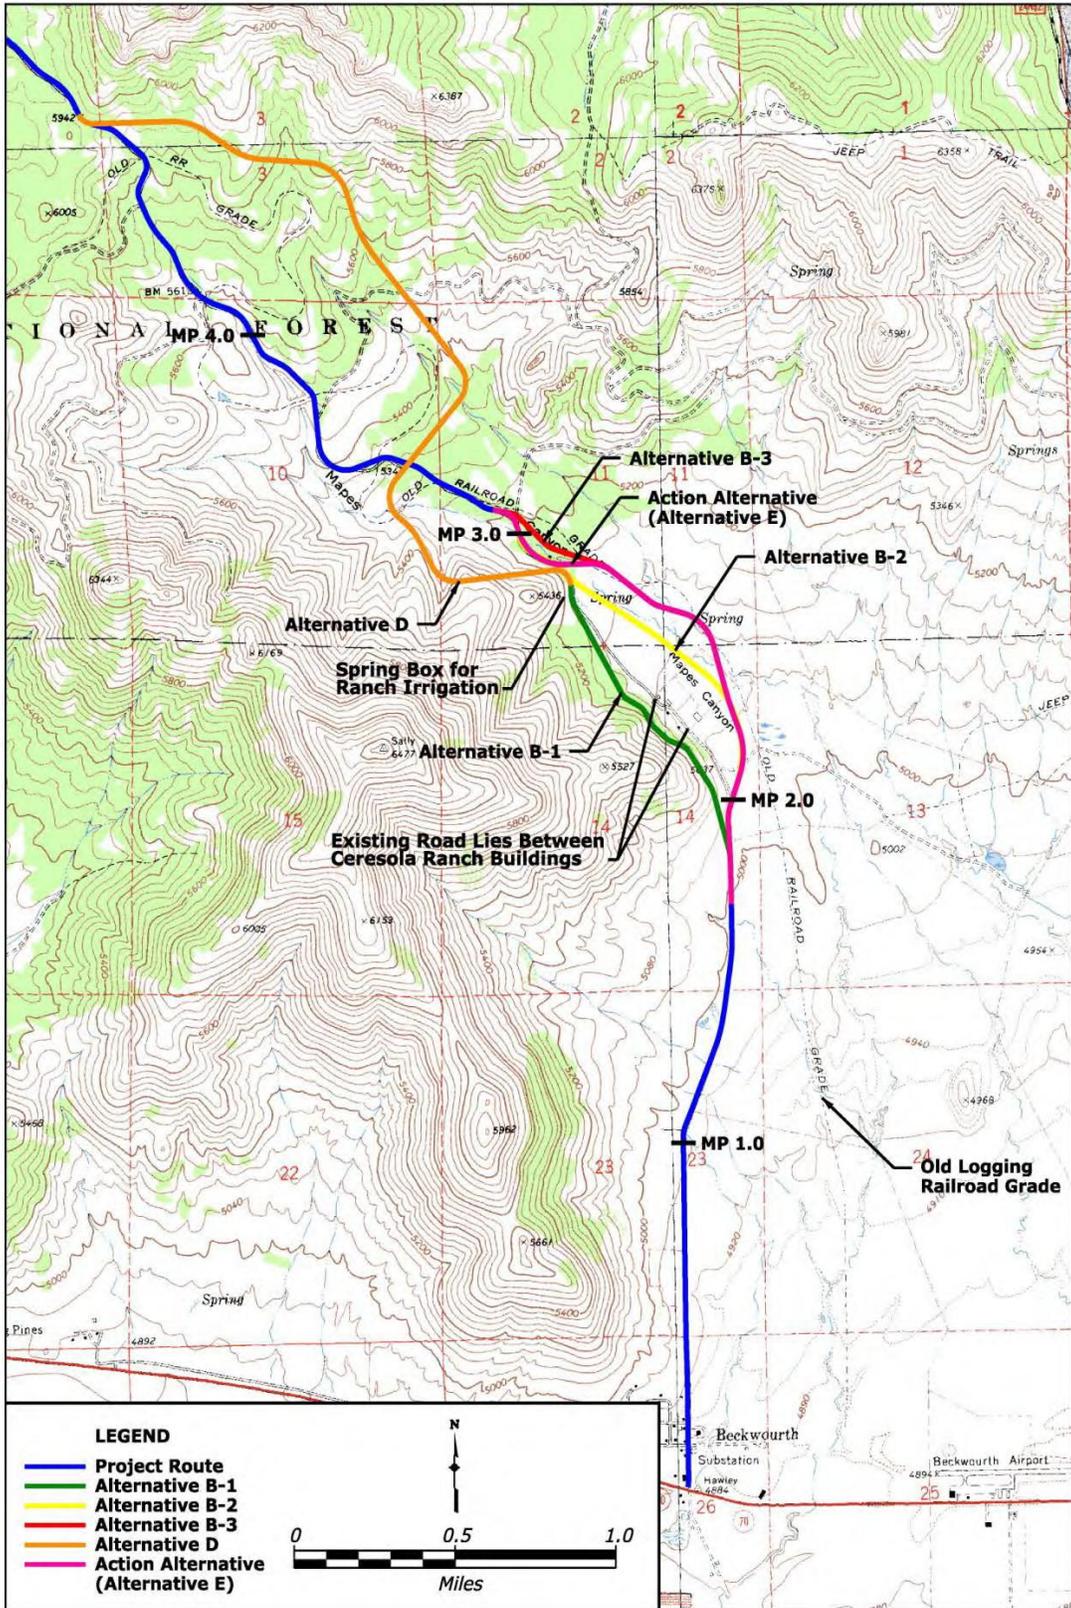
Figure 7. Realignment Options Considered

The Action Alternative analyzed in this EA is named Alternative E and is a derivation of an earlier Alternative B-3 (also referred to as Alternative C), except that it includes a minor alignment shift in Segment 2 for the purposes of impact minimization to the Crocker Meadows Wildlife Area and Clover Valley Lumber Company Railroad grade. Alternative E, as well as the other initially considered options, is depicted in Figure 7.

The realigned roadway in Segment 2 would be constructed to include a consistent 24-foot-wide asphalt surface consisting of a minimum of two, 10-foot travel lanes with 2-foot paved shoulders, and a design speed of 30 mph. The design typical section for Segment 2 is similar to that for Segment 3. The existing FH 177 through this segment would be abandoned after the new alignment is constructed and the easement transferred back to the property owner.
