HAZARDOUS MATERIALS COMMODITIES FLOW STUDY FOR PLUMAS COUNTY, CALIFORNIA

Plumas County Environmental Health

Tait Environmental Services, Inc.

July 2024

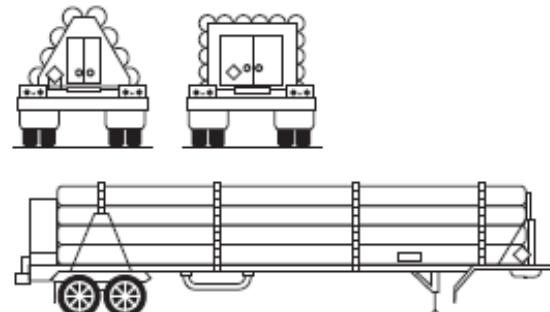
117 Compressed Gas/Tube Trailer

- For pressurized gases (e.g., air, helium, oxygen)
- Long horizontal tubes permanently mounted on a trailer
- Filling and discharge manifold typically located at the rear of trailer

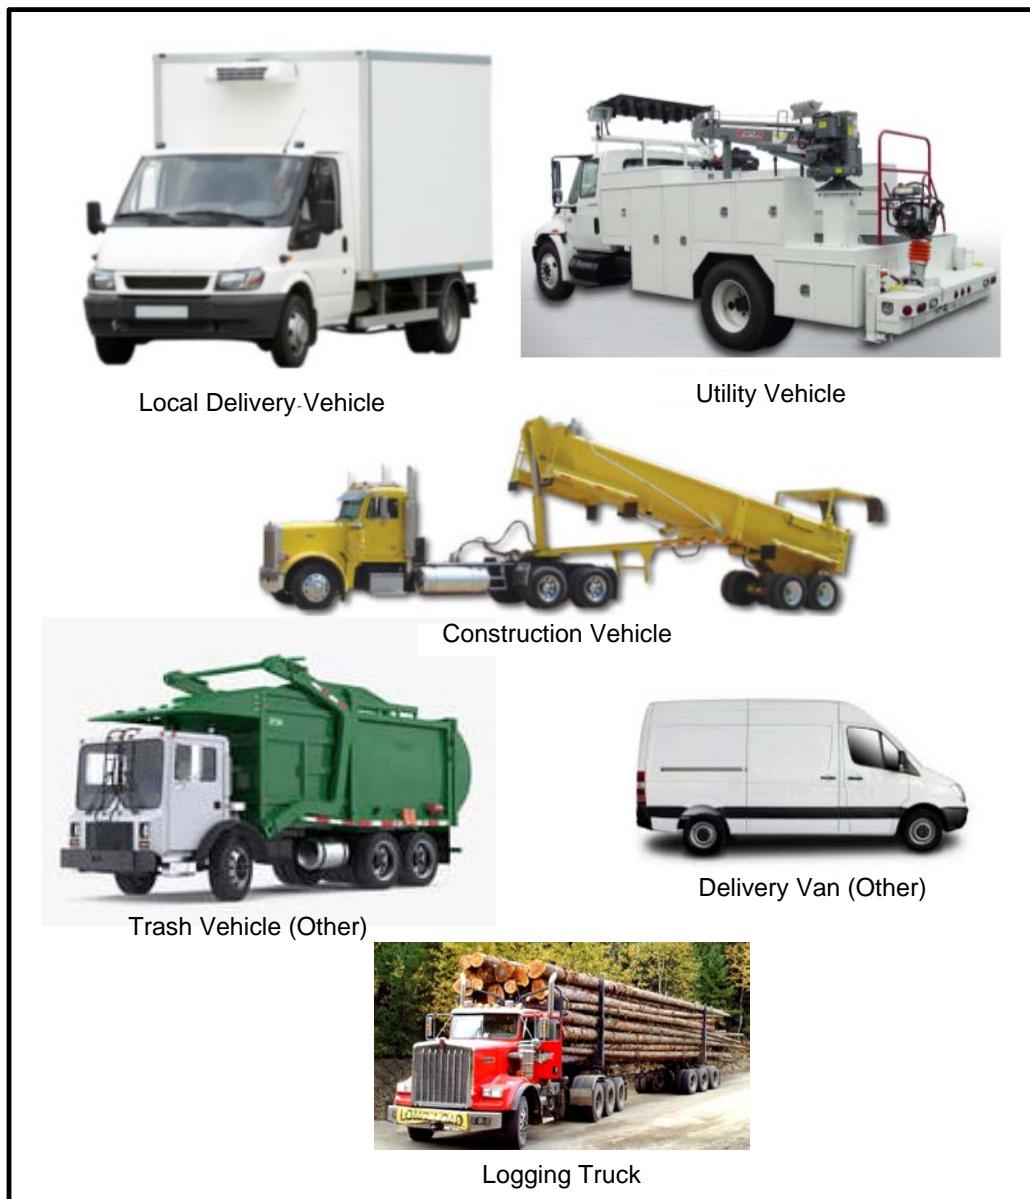
In addition to the vehicles shown in the chart above, there are several other types of vehicles that can be used to transport hazardous materials. These vehicles include local delivery trucks, utility vehicles, and construction vehicles. Local delivery trucks is a

generalized term used to cover vehicles that are variable in size, commonly are single-axle, and are not generally used for long-distance trucking like the semi-truck trailer mixed cargo vehicles shown above. Utility vehicles are variable primarily in design and configuration, and they are often outfitted for specific tasks. Construction vehicles vary in size and may consist of end dumps, concrete trucks, dump trucks, etc. Examples of these vehicles are shown below. Trucks classified as "Other" vehicles may include, but not limited to, delivery vans, trailers pulled by pick-up trucks, or trash trucks. In addition to these vehicles, a significant number of logging trucks were travelling on the highways of Plumas County.

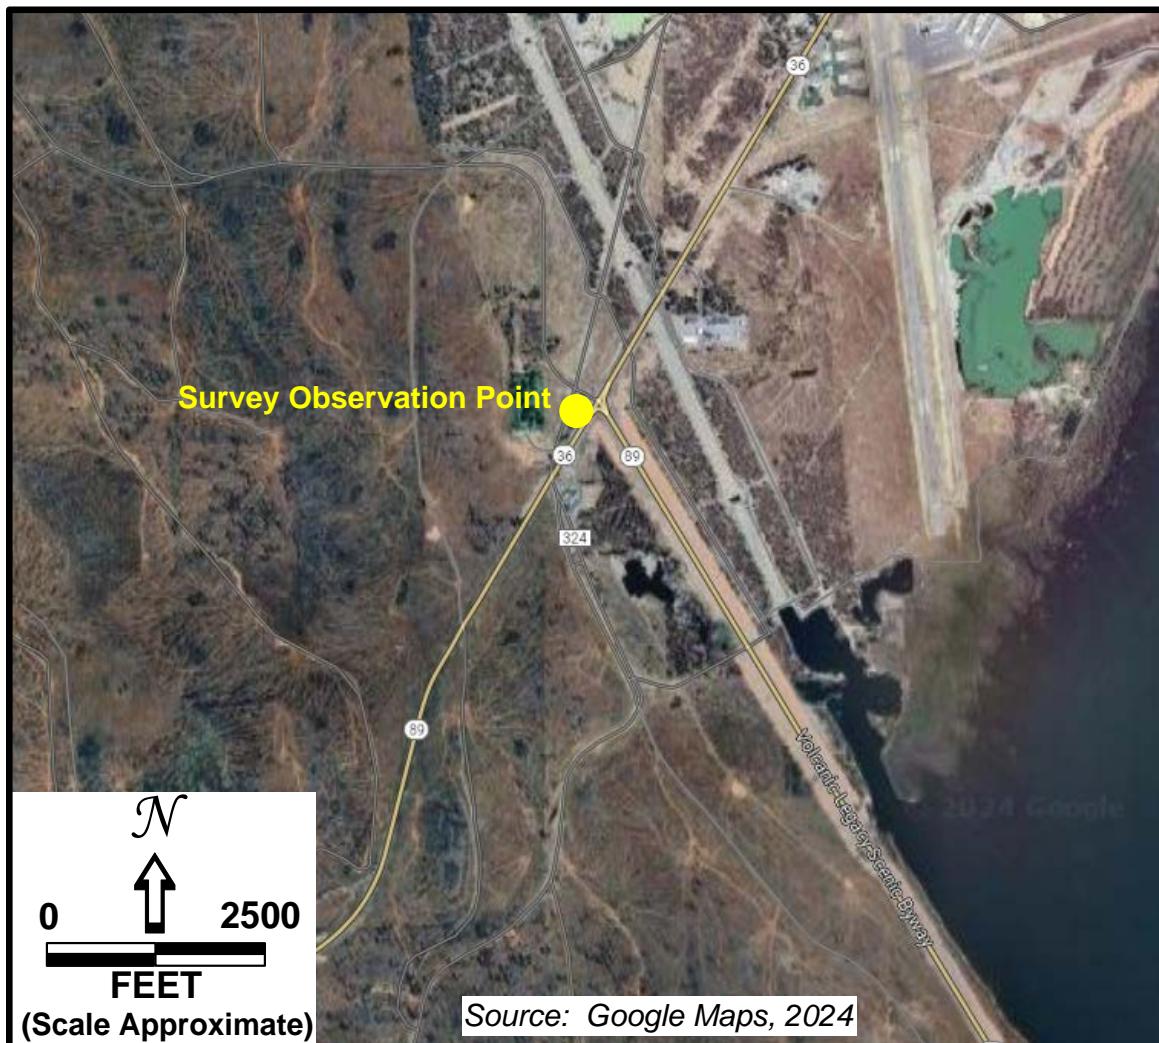
One 6-hour placard survey was performed at the 3-way intersection of Highway 36 and Highway 89 in northern Plumas County. This location is located southwest of the community of Chester and west of Lake Almanor.

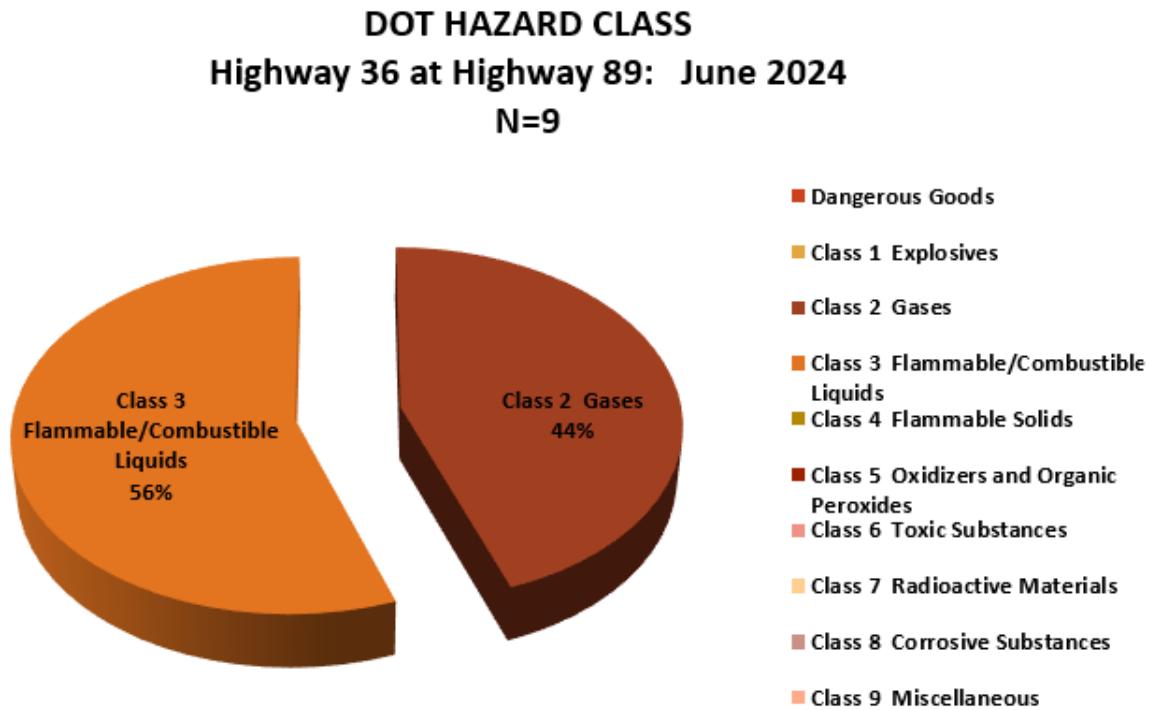
- Propane (1075): 4 trucks (high-pressure tanker)
- Gasoline (1203): 3 trucks (non-pressure tanker)
- Diesel (1993): 2 trucks (non-pressure tanker)

It should be noted that a large double tanker was carrying both diesel and gasoline in the separate tankers. This vehicle was classified as two vehicles for the purposes of this survey. A graphic presentation of hazardous materials travelling through this area during the survey is shown in the charts below.

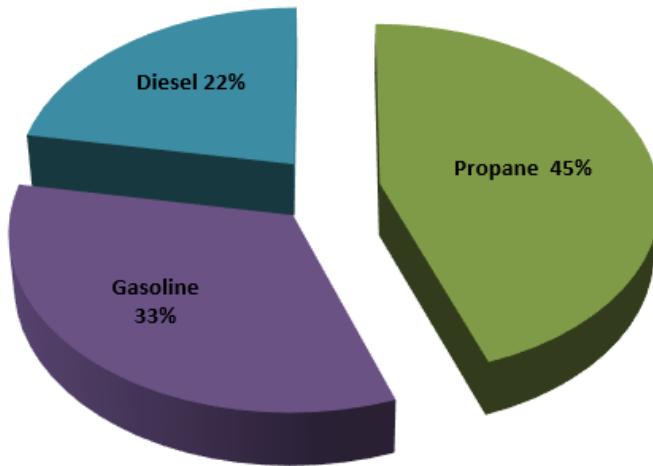
HAZMAT COMMODITIES
Highway 36 at Highway 89: June 2024
N=9

Nine vehicles were placarded, and 185 were not placarded. Hazardous materials included:

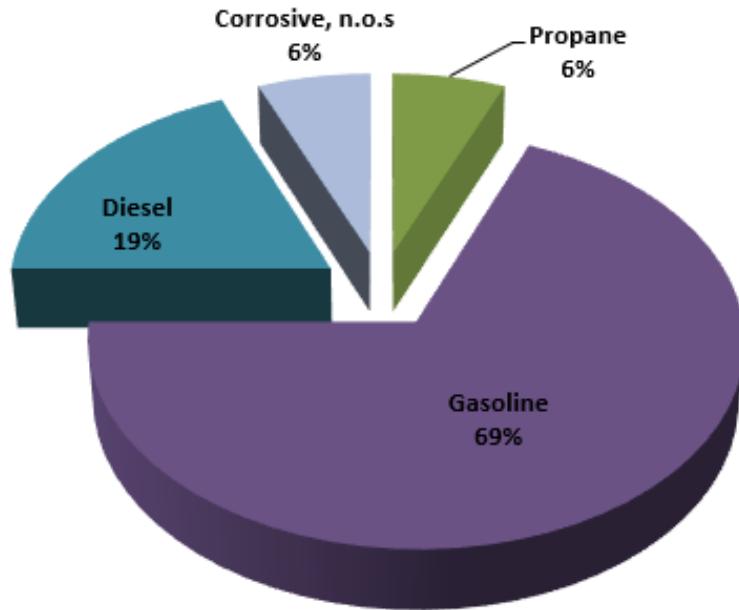
HAZMAT COMMODITIES
Highway 70 at Highway 89 (Indian Falls): June 2024
N=16

Sixteen vehicles were placarded, and 233 were not placarded. Hazardous materials included:

- Propane (1075): 1 truck (high-pressure tanker)
- Gasoline (1203): 4 trucks (non-pressure tanker)
- Diesel (1993): 10 trucks (non-pressure tanker)
- Corrosive materials n.o.s: 1 truck (semi-truck trailer)

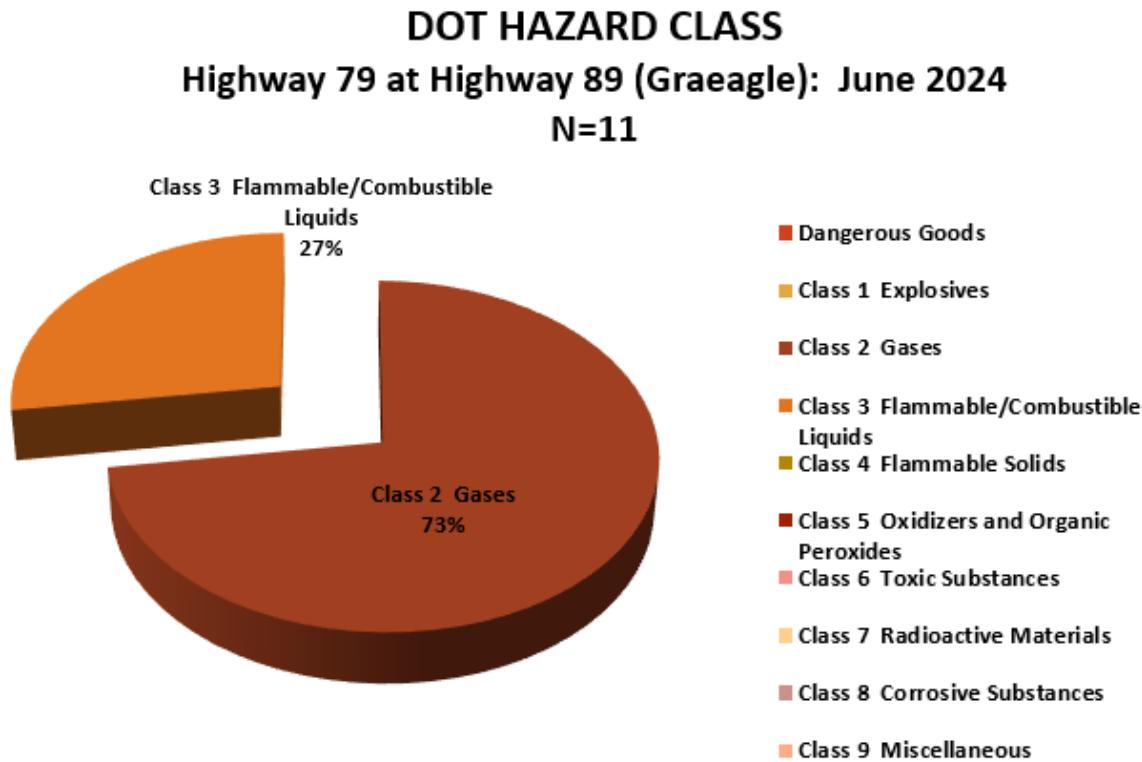
- Propane (1075): 8 trucks (high-pressure tanker)
- Gasoline (1203): 3 trucks (non-pressure tanker)

A graphic presentation of hazardous materials travelling through this area during the survey is shown in the charts below.

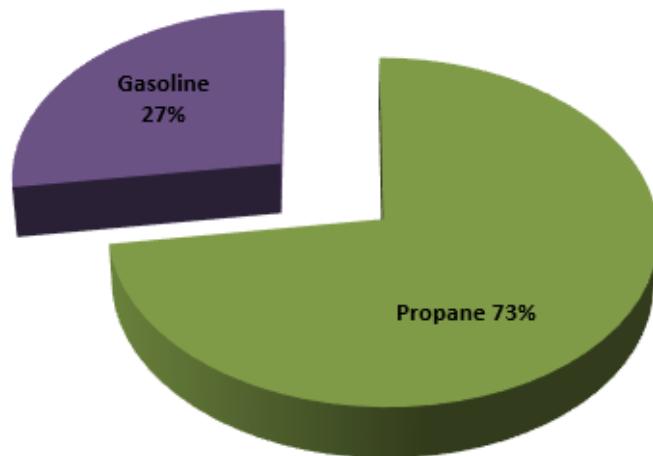
HAZMAT COMMODITIES
Highway 70 at Highway 89 (Graeagle): June 2024
N=11

Eleven vehicles were placarded, and 238 were not placarded. Hazardous materials included:

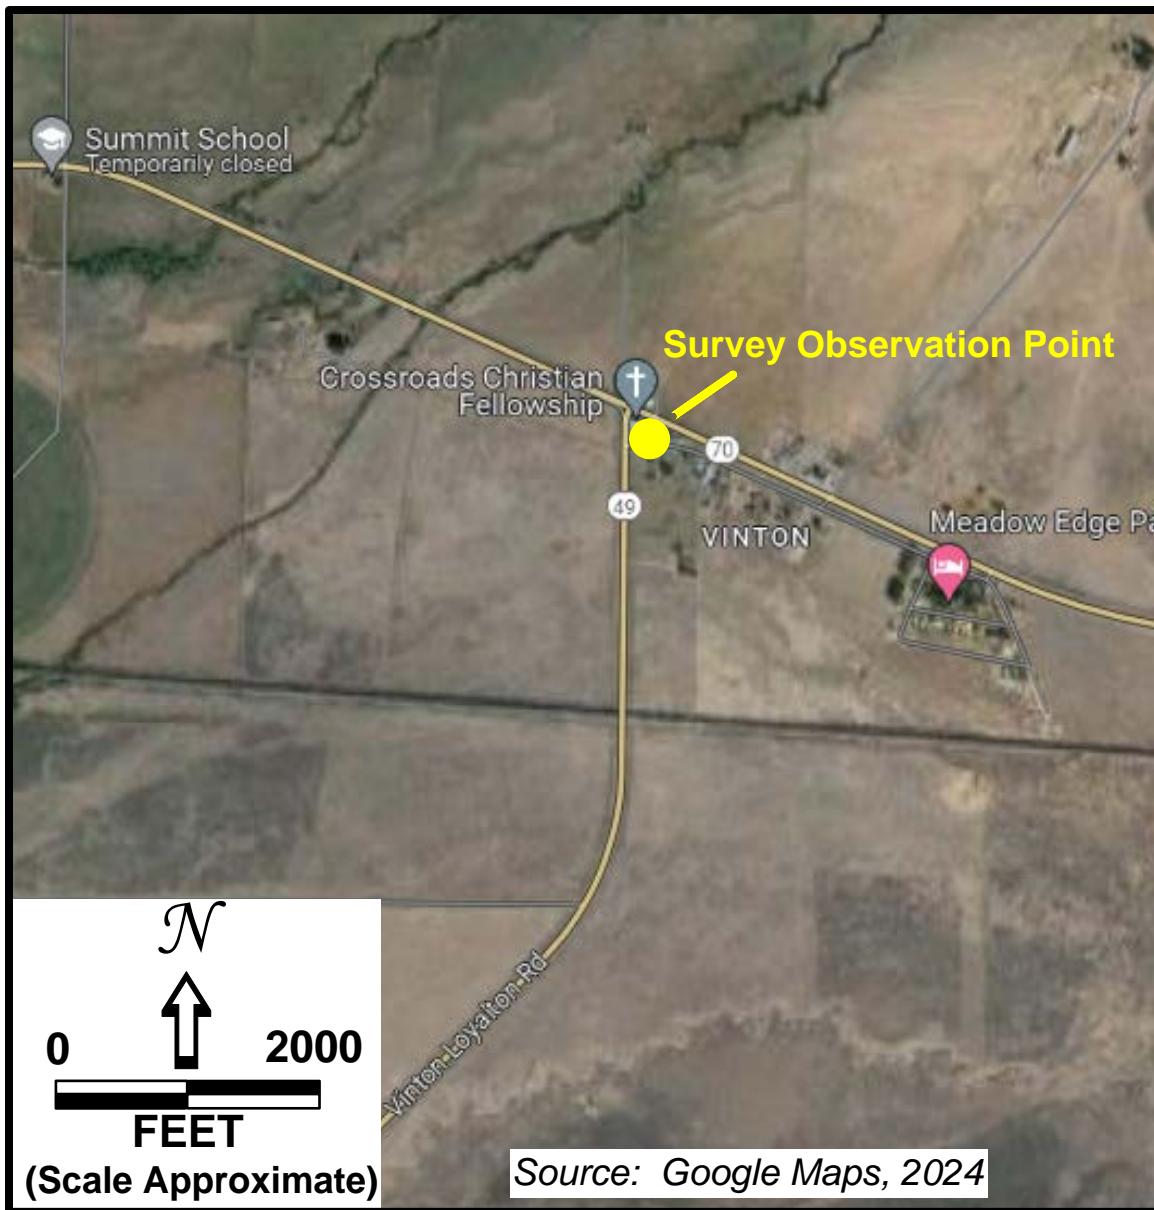
One 6-hour placard survey was performed at the 3-way intersection of Highway 70 and Highway 49 at Vinton in southeastern Plumas County. Highway 70 proceeds east from here where it intersects with U.S. Highway 395 in Lassen County enroute to Reno, Nevada.

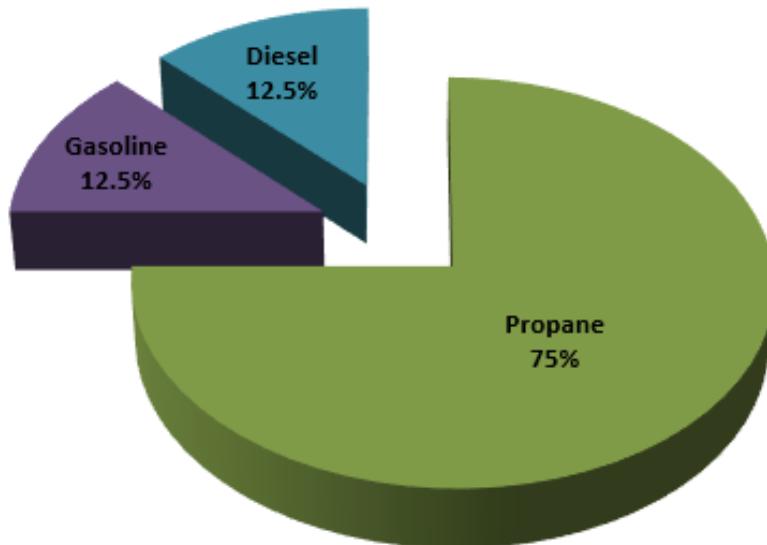
HAZMAT COMMODITIES
Highway 70 at Highway 49: June 2024
N=8

Eight vehicles were placarded, and 118 were not placarded. Hazardous materials included:

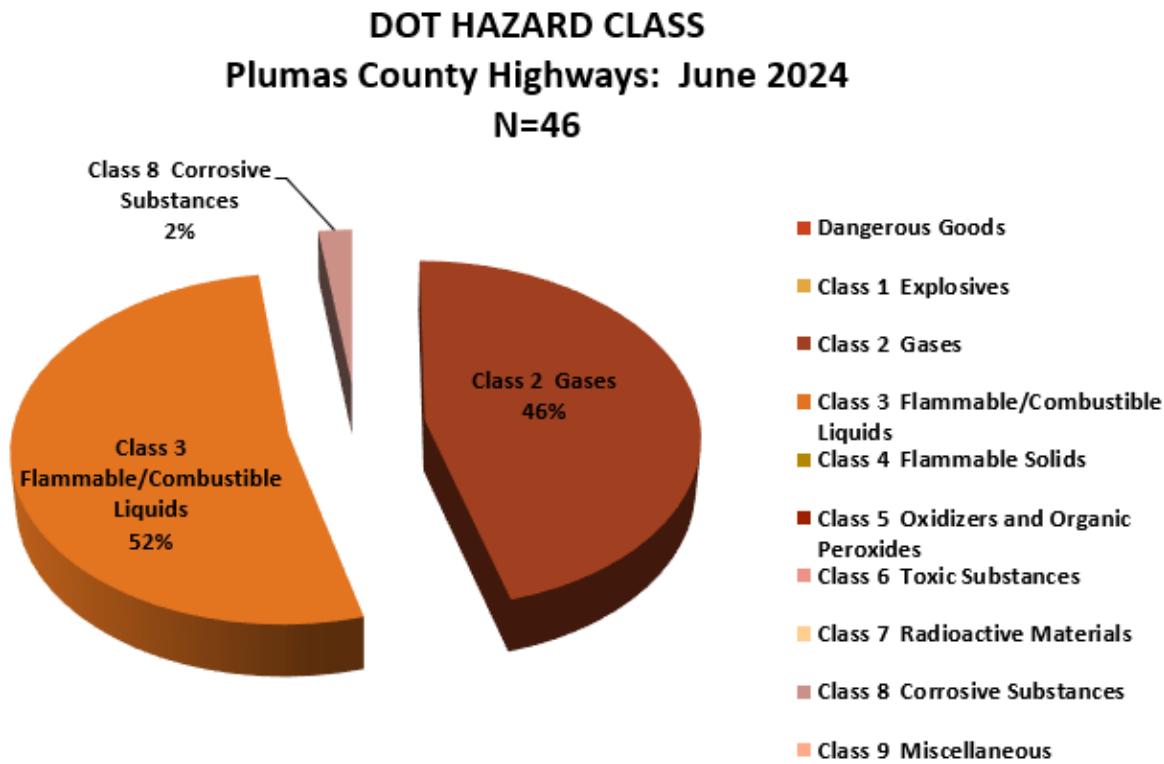
An evaluation of the hazardous materials transportation along the highways and roadways within Plumas County is provided based on the information contained above in Sections 2.3.1 through 2.3.5. A total of 931 trucks travelled through these observation points during the survey, and 45 of the vehicles were placarded with hazardous materials.

A summary of the general categories of hazardous materials travelling along the highways and roadways of Plumas County during the survey are shown in the charts below.

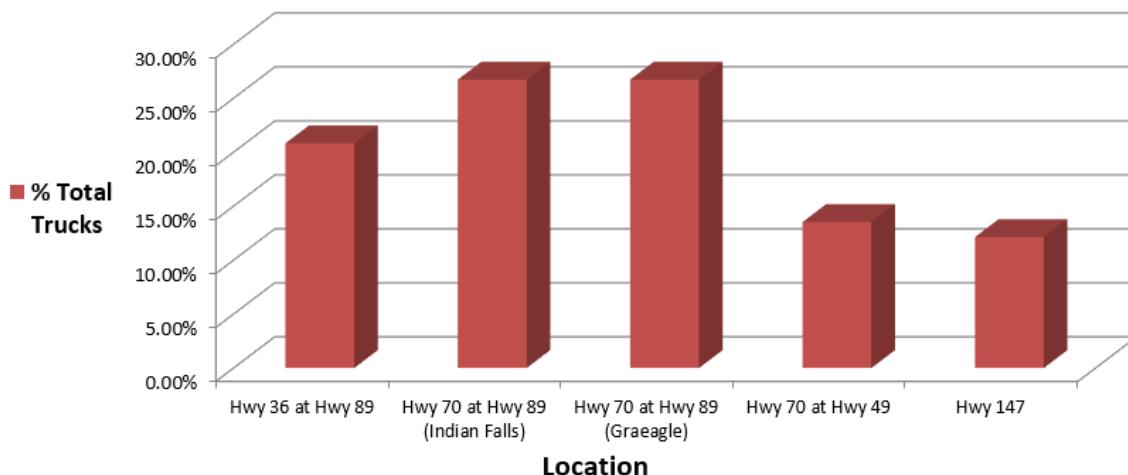
PLUMAS COUNTY % TOTAL TRUCKS: JUNE 2024

Trucks were categorized by the types of vehicles as discussed in Section 2.2. The truck type categories have been generalized as follows:

- Tankers (all types)
- Semi-Truck Trailers
- Local Delivery Vehicles
- Dry Bulk Cargo Carriers
- Logging Trucks
- Construction Vehicles
- Utility Vehicles
- Other Vehicles

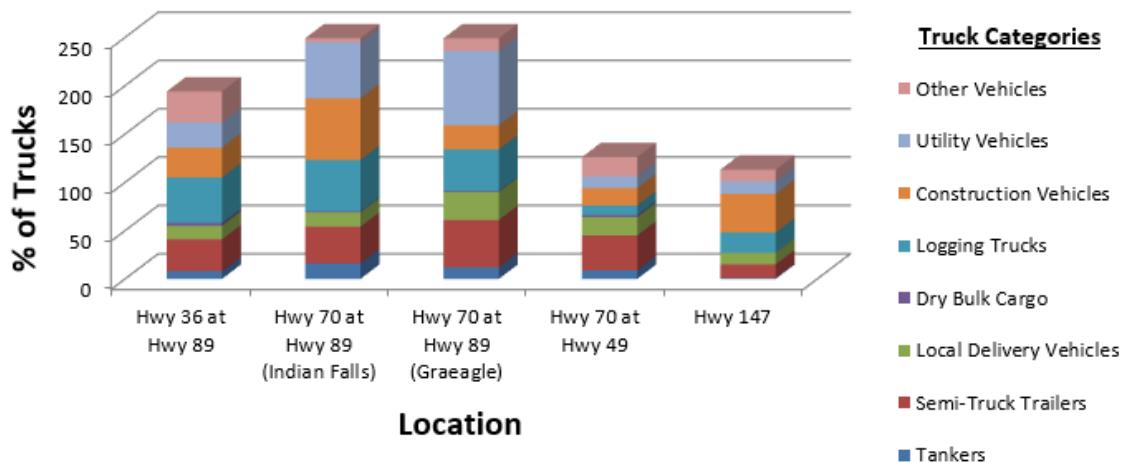
PLUMAS COUNTY % TRUCK TRAFFIC BY VEHICLE TYPE: JUNE 2024

Total truck traffic as shown in the above chart can be summarized as follows:

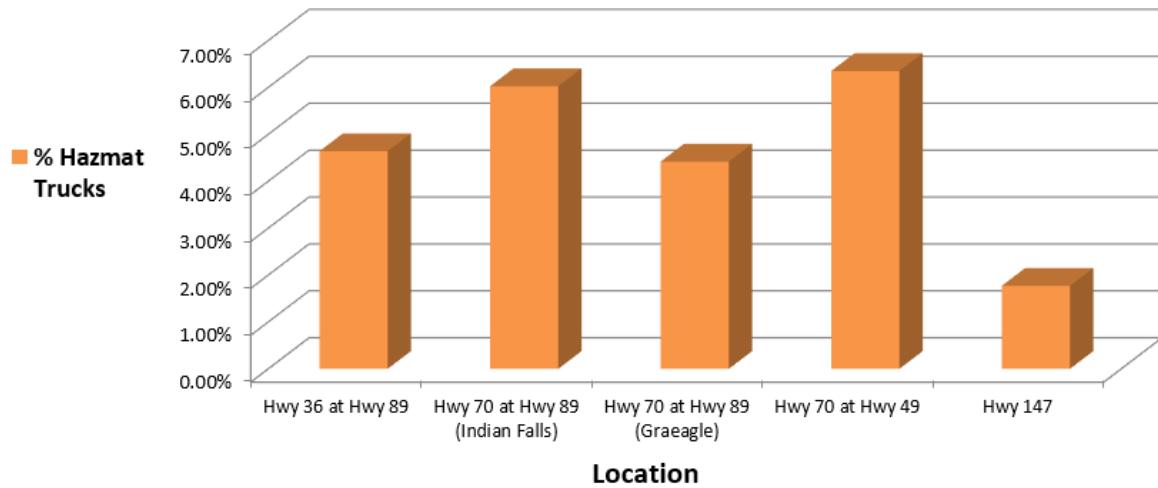
PLUMAS COUNTY % HAZMAT TRUCKS: JUNE 2024

The movement of hazardous materials through Plumas County as a percentage of the total truck traffic is summarized in the following chart.

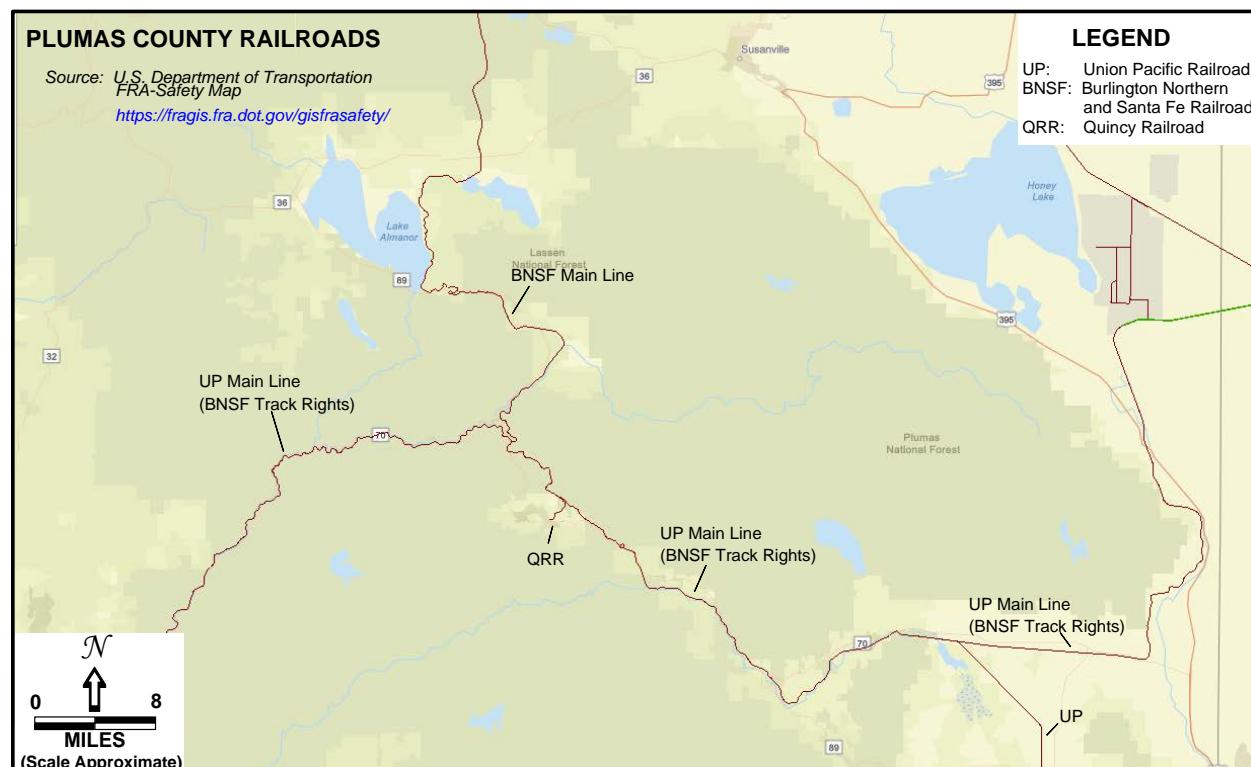
Railroad transportation within Plumas County occurs along two major rail lines. The Union Pacific Railroad (UP) main line runs adjacent to and parallel to Highway 70 and along Highway 89 in the central part of the County. The Burlington Northern and Santa Fe Railroad (BNSF) main line runs generally adjacent to and parallel to Highway 89 in the northern part of the County, and BNSF has track rights along the UP main line along Highway 70. The Quincy Railroad (QRR) operates a 3.27-mile spur line in Quincy that connects the Sierra Pacific lumber mill with the UP main line. A map showing the rail lines in Plumas County is shown below.

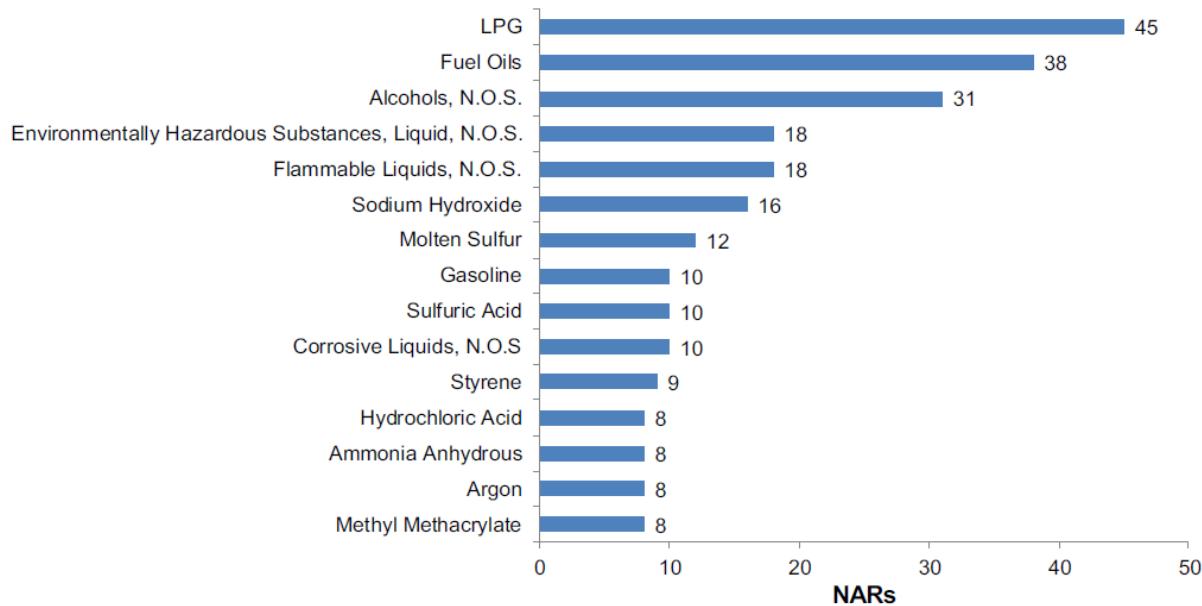
U.S. and Canada: 2019

It should be noted that the top two commodities (LPG and Fuel Oils) are the dominant hazardous materials being transported through Plumas County. NARs in California for 2019 included: tank car (42) and intermodal (26) for a total of 68 releases incidents.

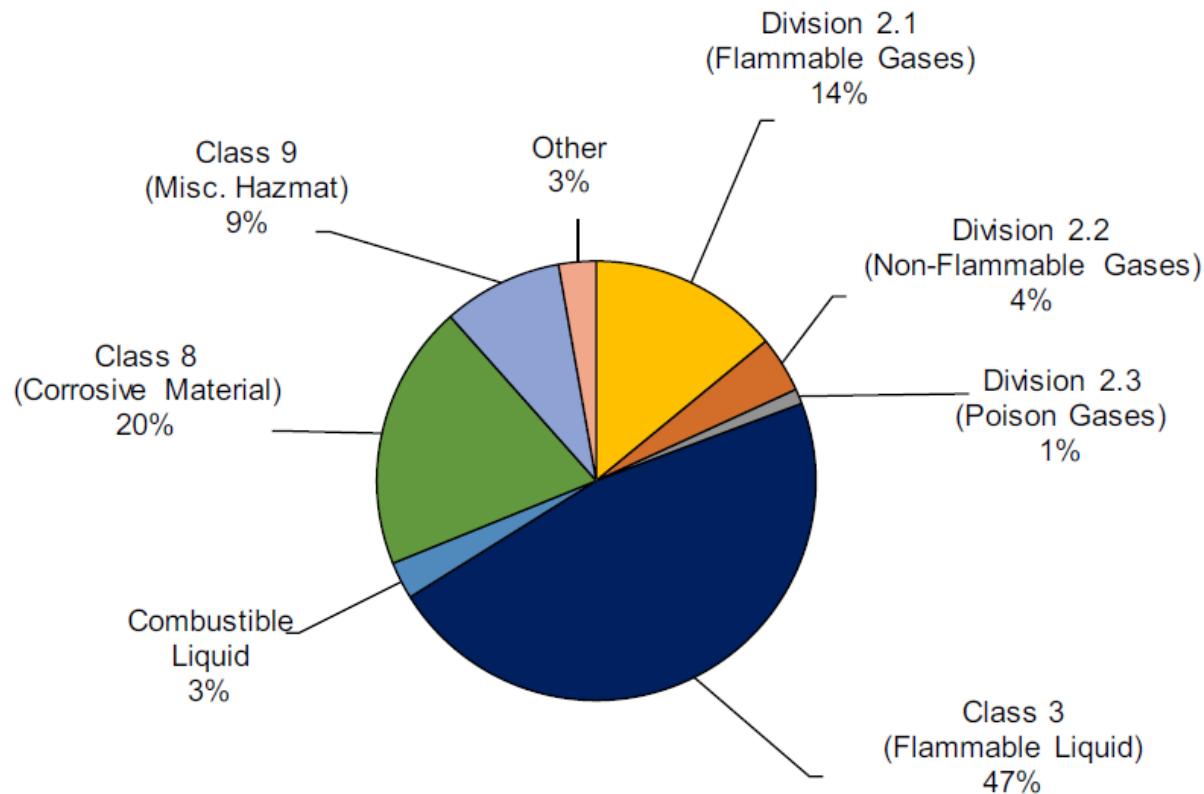
Exhibit 4
Tank Car Non-Accident Releases by Hazard Class
U.S. and Canada: 2019

The report lists the following information with respect to hazard class:

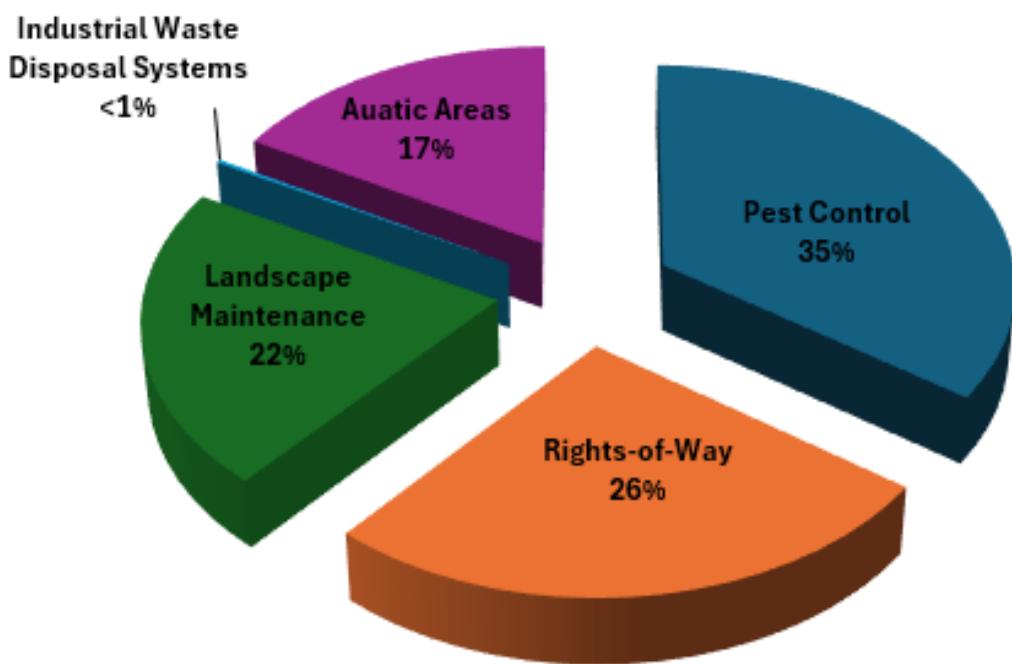
Non-Agricultural % Pesticide Usage - Plumas County 2021

The use and transportation of agricultural chemicals varies by location. In general, agricultural chemical transportation is from the vendor to the user, and this is usually completed by shipping small quantities of chemicals throughout the area, as necessary. No placarded trucks containing pesticides were observed during the survey.

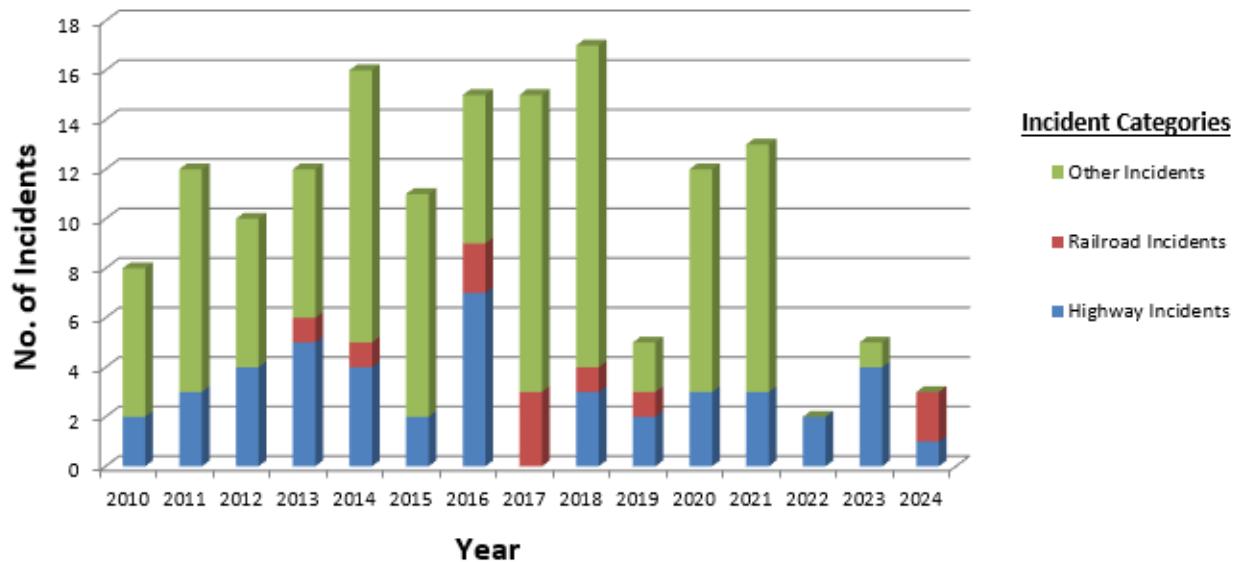
PLUMAS COUNTY ENVIRONMENTAL HEALTH INCIDENTS: 2010-2024

There is variability in the transportation incidents throughout the time frame; however, the highway incidents occur more frequently than the railroad incidents.
