SUBJECT: A tractor operator died when his tractor rolled over on him.

SUMMARY
California FACE Report #04CA009

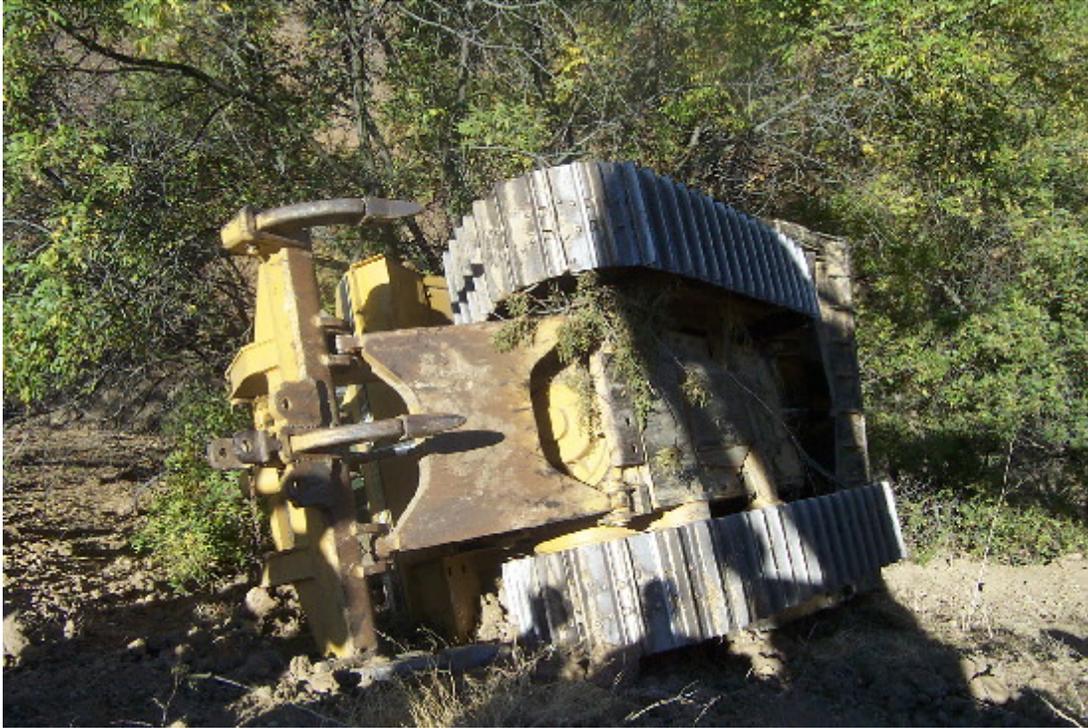
Exhibit #4. A closer view of the tractor involved in the incident after it stopped rolling.
