MONUMENT DESCRIPTIONS

BY JOHNSON - FRANK & ASSOC., INC.

SHEET 9 OF 13

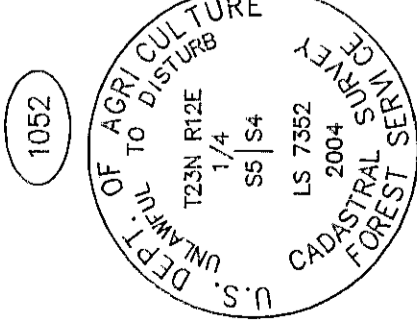
FOUND 5/8" STEEL ROD WITH 3 1/4" ALUMINUM CAP PER RECORD OF SURVEY, 14 RS 7, PLUMAS COUNTY, IN ROCK MOUND AND POST WITH FOREST SERVICE 54-9 MONUMENT SIGN 3' NORTHERLY OF MONUMENT. ACCEPTED AS QUARTER CORNER BETWEEN SECTIONS 5 AND 4, TOWNSHIP 22 NORTH, RANGE 12 EAST, MOUNT DIABLO MERIDIAN. CORNER LIES ON FLAT GROUND IN MODERATE PINE FOREST. APPROXIMATELY 1000 FEET SOUTHERLY OF INTERSECTION OF HIGHWAY 70 AND BONITA RIDGE ROAD. MONUMENT IS IN EXCELLENT CONDITION. REBUILT AND ADDED TO ROCK MOUND (3' DIAMETER, 8" IN HEIGHT) SET POST WITH FOREST SERVICE 54-9 MONUMENT SIGN 2 FEET EASTERLY OF MONUMENT. FOUND EXISTING BEARING TREES, SET MAG SPIKES FOR BEARINGS AND DISTANCES, PAINTED BLAZES AND 6" RINGS, 6' ABOVE GROUND, CLEARED BRUSH FROM MONUMENT TO BEARING TREES, ADDED FOREST SERVICE 54-3 BEARING TREE SIGN AND FOREST SERVICE 54-9 MONUMENT SIGN ON BACK OF TREES.

1052BT NW N78°01'W - 18.3' 11" PONDEROSA PINE
1052BT NE N48°43'E - 36.2' 17" PONDEROSA PINE

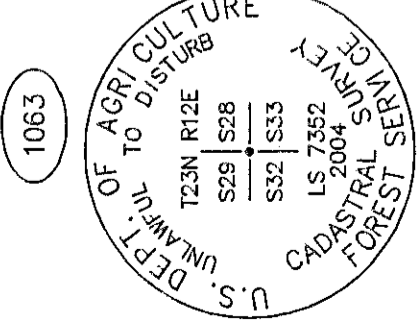
FOUND 5/8" STEEL ROD WITH 3 1/4" ALUMINUM CAP PER RECORD OF SURVEY, 14 RS 7, PLUMAS COUNTY, IN ROCK MOUND AND POST WITH FOREST SERVICE 54-9 MONUMENT SIGN LYING NEARBY. ACCEPTED AS THE SECTION CORNER COMMON TO SECTIONS 28, 29, 32 AND 33, TOWNSHIP 23 NORTH, RANGE 12 EAST, MOUNT DIABLO MERIDIAN. CORNER IS ON STEEP NORTHERLY FACING SLOPE IN DENSE CEDAR, FIR AND PONDEROSA PINE FOREST. MONUMENT IS IN EXCELLENT CONDITION, REBUILT AND ADDED TO ROCK MOUND (3' DIAMETER, 8" IN HEIGHT) SET POST WITH FOREST SERVICE 54-9 MONUMENT SIGN 2 FEET NORTHERLY OF MONUMENT. FOUND EXISTING BEARING TREES, SET MAG SPIKES FOR BEARINGS AND DISTANCES, PAINTED BLAZES AND 6" RINGS, 5' ABOVE GROUND, ADDED NEW FOREST SERVICE 54-3 BEARING TREE SIGN.

1063BT NW1 N59°17'W - 29.2' 48" DOUGLAS FIR
1063BT NW2 N74°10'W - 4.2' 11" PONDEROSA PINE
1063BT SE S65°46'E - 19.8' 9" PONDEROSA PINE

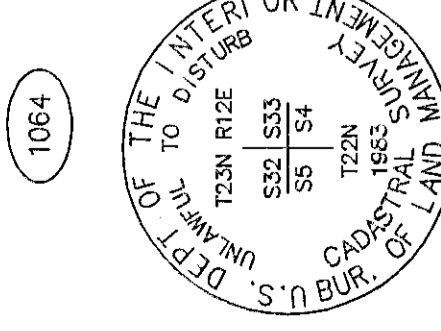
FOUND 2 1/2" ALUMINUM PIPE WITH BLM 3 1/4" ALUMINUM CAP PER RECORD OF SURVEY, 14 RS 7, PLUMAS COUNTY, IN ROCK MOUND AND POST WITH FOREST SERVICE 54-2 BOUNDARY SIGN AND FOREST SERVICE 54-9 MONUMENT SIGN 2 FEET NORTHERLY OF MONUMENT. ACCEPTED AS THE SECTION CORNER COMMON TO SECTIONS 32 AND 33, TOWNSHIP 23 NORTH, RANGE 12 EAST, AND SECTIONS 4 AND 5, TOWNSHIP 22 NORTH, RANGE 12 EAST, MOUNT DIABLO MERIDIAN. CORNER LIES ON STEEP SOUTHERLY FACING SLOPE IN CLEARING WITH SPARSE CEDAR, FIR AND PONDEROSA PINE TREES. MONUMENT IS IN EXCELLENT CONDITION, REBUILT AND ADDED TO ROCK MOUND (3' DIAMETER, 8" IN HEIGHT) SET POST WITH FOREST SERVICE 54-9 MONUMENT SIGN 2 FEET EASTERLY OF MONUMENT. FOUND EXISTING BEARING TREES, SET MAG SPIKES FOR BEARINGS AND DISTANCES, PAINTED BLAZES AND 6" RINGS, 6' ABOVE GROUND, CLEARED BRUSH FROM MONUMENT TO BEARING TREES, ADDED NEW FOREST SERVICE 54-3 BEARING TREE SIGN.

1064BT NW N70°13'W - 52.2' 26" PONDEROSA PINE
1064BT NE N11°09'E - 53.7' 22" PONDEROSA PINE
1064BT SE S11°45'E - 19.7' 17" DOUGLAS FIR
1064BT SW S80°09'W - 13.6' 12" DOUGLAS FIR

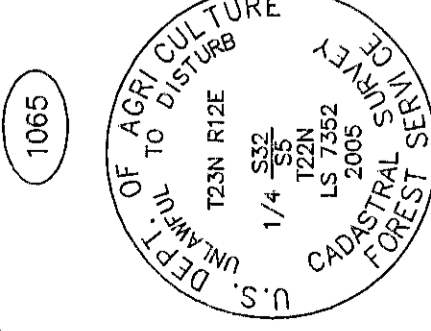
FOUND 5/8" STEEL ROD WITH 3 1/4" ALUMINUM CAP PER RECORD OF SURVEY, 14 RS 7, PLUMAS COUNTY, IN ROCK MOUND AND POST WITH FOREST SERVICE 54-9 MONUMENT SIGN 3 FEET EASTERLY. ACCEPTED AS THE QUARTER SECTION CORNER COMMON TO SECTIONS 32, TOWNSHIP 23 NORTH, RANGE 12 EAST, AND SECTION 5, TOWNSHIP 22 NORTH, RANGE 12 EAST, MOUNT DIABLO MERIDIAN. CORNER LIES ON GENTLE EAST FACING SLOPE IN SPARSE FIR AND PONDEROSA PINE FOREST. MONUMENT IS IN EXCELLENT CONDITION, REBUILT AND ADDED TO ROCK MOUND (3' DIAMETER, 8" IN HEIGHT) SET POST WITH FOREST SERVICE 54-9 MONUMENT SIGN 2 FEET NORTHERLY OF MONUMENT. FOUND EXISTING BEARING TREES, SET MAG SPIKES FOR BEARINGS AND DISTANCES, PAINTED BLAZES AND 6" RINGS, 6' ABOVE GROUND, ADDED NEW FOREST SERVICE 54-3 BEARING TREE SIGN AND FOREST SERVICE 54-9 MONUMENT SIGN ON BACK OF TREES.

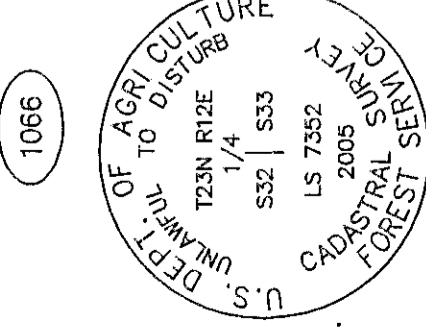
FOUND 5/8" STEEL ROD WITH 3 1/4" ALUMINUM CAP PER RECORD OF SURVEY, 14 RS 7, PLUMAS COUNTY, IN ROCK MOUND AND POST WITH FOREST SERVICE 54-2 BOUNDARY SIGN AND FOREST SERVICE 54-9 MONUMENT SIGN 3 FEET SOUTHWESTERLY. ACCEPTED AS THE QUARTER SECTION CORNER COMMON TO SECTIONS 32 AND 33, TOWNSHIP 23 NORTH, RANGE 12 EAST, MOUNT DIABLO MERIDIAN. CORNER LIES ON SOUTH FACING MODERATELY STEEP SLOPE IN MIXED CEDAR, FIR AND PINE FOREST. MONUMENT IS IN EXCELLENT CONDITION, REBUILT AND ADDED TO ROCK MOUND (3' DIAMETER, 8" IN HEIGHT). FOUND EXISTING BEARING TREES AND BEARING OBJECTS, SET MAG SPIKES FOR BEARINGS AND DISTANCES, PAINTED BLAZES AND 6" RINGS, 6' ABOVE GROUND, ADDED NEW FOREST SERVICE 54-3 BEARING TREE SIGN AND FOREST SERVICE 54-9 MONUMENT SIGN ON BACK OF TREES.

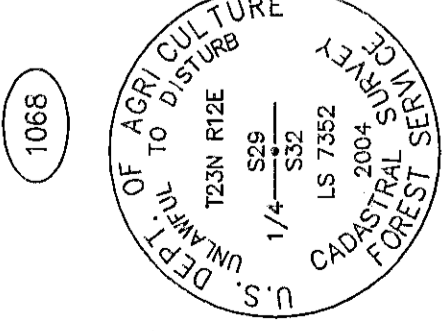
FOUND 5/8" STEEL ROD WITH 3 1/4" ALUMINUM CAP PER RECORD OF SURVEY, 14 RS 7, PLUMAS COUNTY, IN SMALL ROCK MOUND AND POST WITH FOREST SERVICE 54-9 MONUMENT SIGN 1 FOOT EASTERLY. ACCEPTED AS THE QUARTER SECTION CORNER COMMON TO SECTIONS 29 AND 32, TOWNSHIP 23 NORTH, RANGE 12 EAST, MOUNT DIABLO MERIDIAN. CORNER LIES ON FLAT GROUND IN PLANTATION FOREST. MONUMENT IS IN EXCELLENT CONDITION, REBUILT AND ADDED TO ROCK MOUND (2' DIAMETER, 6" IN HEIGHT) SET POST WITH FOREST SERVICE 54-9 MONUMENT SIGN 2 FEET NORTHERLY OF MONUMENT. FOUND EXISTING BEARING TREE. SET MAG SPIKE FOR BEARINGS AND DISTANCES, PAINTED BLAZES AND 6" RINGS, 5' ABOVE GROUND, ADDED NEW FOREST SERVICE 54-3 BEARING TREE SIGN. MADE NEW BEARING TREES, BASE BLAZED AND SCRIBED, SET MAG SPIKE FOR CHAINING POINT AT BASE CENTER, ETCHED 6" RING, 6' ABOVE GROUND, PAINTED BLAZE AND 6" RING, ADDED FOREST SERVICE 54-3 BEARING TREE SIGNS.

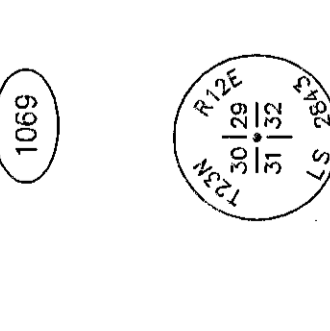
FOUND 5/8" REBAR WITH 1 1/2" ALUMINUM CAP PER RECORD OF SURVEY, 14 RS 7, PLUMAS COUNTY, IN A ROCK MOUND. ACCEPTED AS THE SECTION CORNER COMMON TO SECTIONS 29, 30, 31 AND 32, TOWNSHIP 23 NORTH, RANGE 12 EAST, MOUNT DIABLO MERIDIAN. CORNER LIES ON A MODERATELY STEEP WEST FACING SLOPE BETWEEN HIGHWAY 70 AND TWO RIVERS ROAD IN DENSE PINE FOREST. MONUMENT IS IN EXCELLENT CONDITION, CLEARED DEBRIS, REBUILT ROCK MOUND (3' DIAMETER, 8" IN HEIGHT) SET POST WITH FOREST SERVICE 54-9 MONUMENT SIGN 2 FEET NORTHEASTERLY OF MONUMENT. FOUND 3 EXISTING BEARING TREES, 12" PINE PAINTED SMALL BLAZE 4' ABOVE GROUND AND 6" RING, 6' ABOVE GROUND, 35" PINE STUMP DECAYING WITH NO BLAZE, PAINTED RING AROUND TOP OF STUMP, 14" PINE PAINTED SMALL BLAZE 4' ABOVE GROUND AND 6" RING, 6' ABOVE GROUND, SET MAG SPIKE FOR BEARINGS AND DISTANCES FOR ALL AND REPLACED WITH NEW FOREST SERVICE 54-3 BEARING TREE SIGN FOR ALL.

1069BT SW1 S66°09'W - 9.3' 12" PONDEROSA PINE
1069BT SW2 S59°53'W - 35.2' 35" PONDEROSA PINE STUMP
1069BT SE S70°13'E - 13.3' 14" PONDEROSA PINE
