## CORNER RECORD

Document Number 101Portion of Section 6, T. 23 N., R. 14. E., M.D.M. County of Plumas, CaliforniaBrief Legal Description NW corner Lot 74, Crocker Mountain Estates, 3 M 44

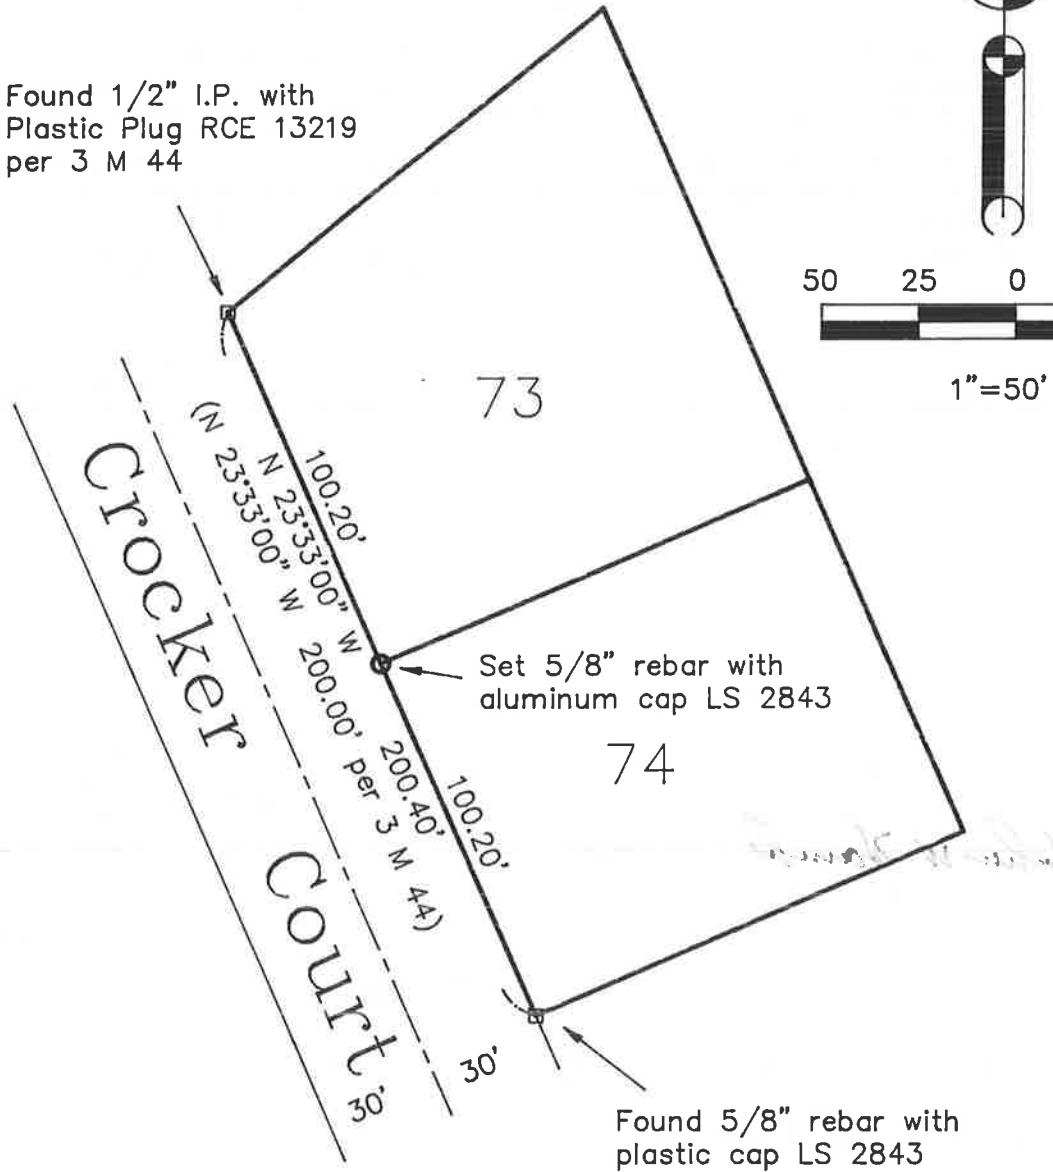
Identification and type of corner found: Evidence used to identify or procedure used to establish or reestablish the corner:  
Found 1/2" I.P. with Plastic Plug, barely legible, stamped RCE 13219 for Northwest corner of Lot 73 also found 5/8" rebar with plastic cap stamped LS 2843 which I accepted for the Southwest corner of Lot 74, from which I established the Northwest corner of Lot 74 between the two found corners.

A description of the physical condition of the monument as found and as set or reset: Set 5/8" rebar with aluminum cap stamped LS 2843 for Northwest corner of Lot 74 which is also the Southwest corner of Lot 73.

Found 1/2" I.P. with  
Plastic Plug RCE 13219  
per 3 M 44
