## CORNER RECORD

Document Number 298

County of Plumas, CaliforniaBrief Legal Description Lot 8 Block 50 Second North Addition to Portola Townsite  
Book A Maps page 30.

Lot 8 Block 50  
Second North Addition  
Portola Townsite  
A Maps 30

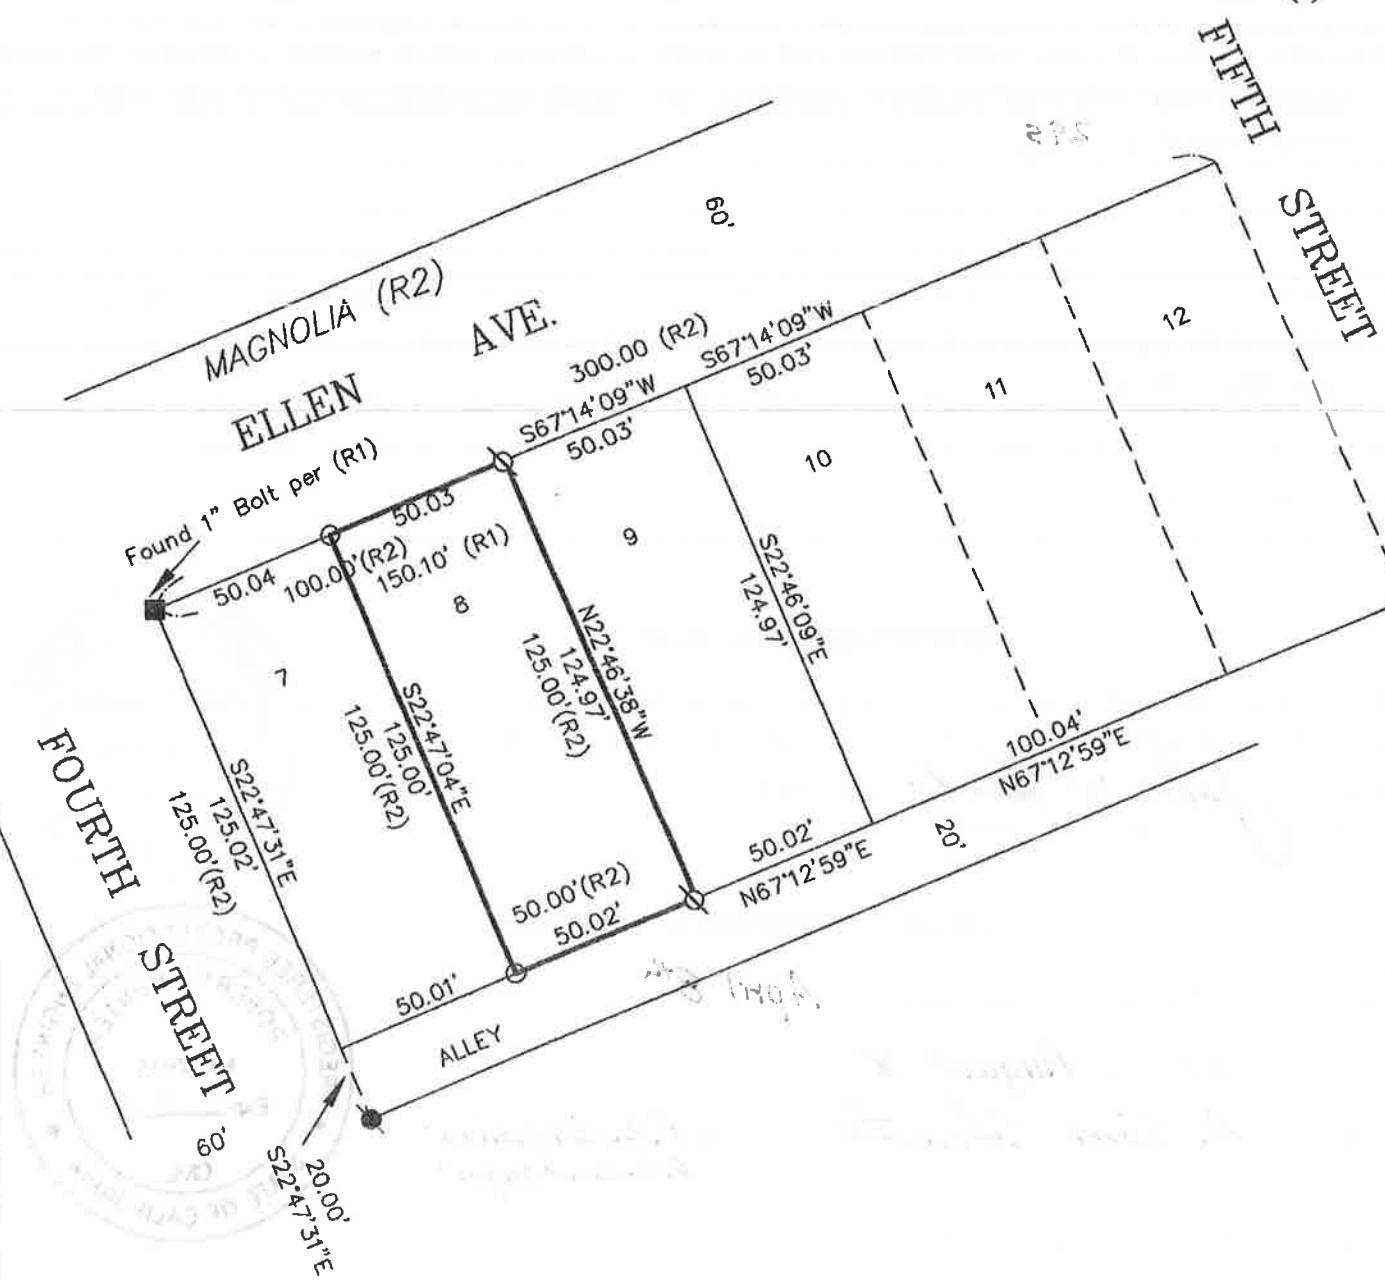
*Found corners indicated in good condition, as shown on corner record # 200 AND corner record # 295.*A description of the physical condition of the monument as found and as set or reset:  
*see note above.*

- FOUND 5/8" rebar with cap LS 2843 per corner record 200.
- FOUND point as described
- FOUND 5/8" rebar with aluminum cap LS 2843 per corner record # 295
  - SET 5/8" Rebar & Aluminum Cap LS 2843 (R1) per corner record # 200
  - (R2) per A Maps 30
