CORNER RECORD

Document Number 328

City of _____ County of Plumas, California

Brief Legal Description W 1/4 Section 26, T28N, R8E, MDM

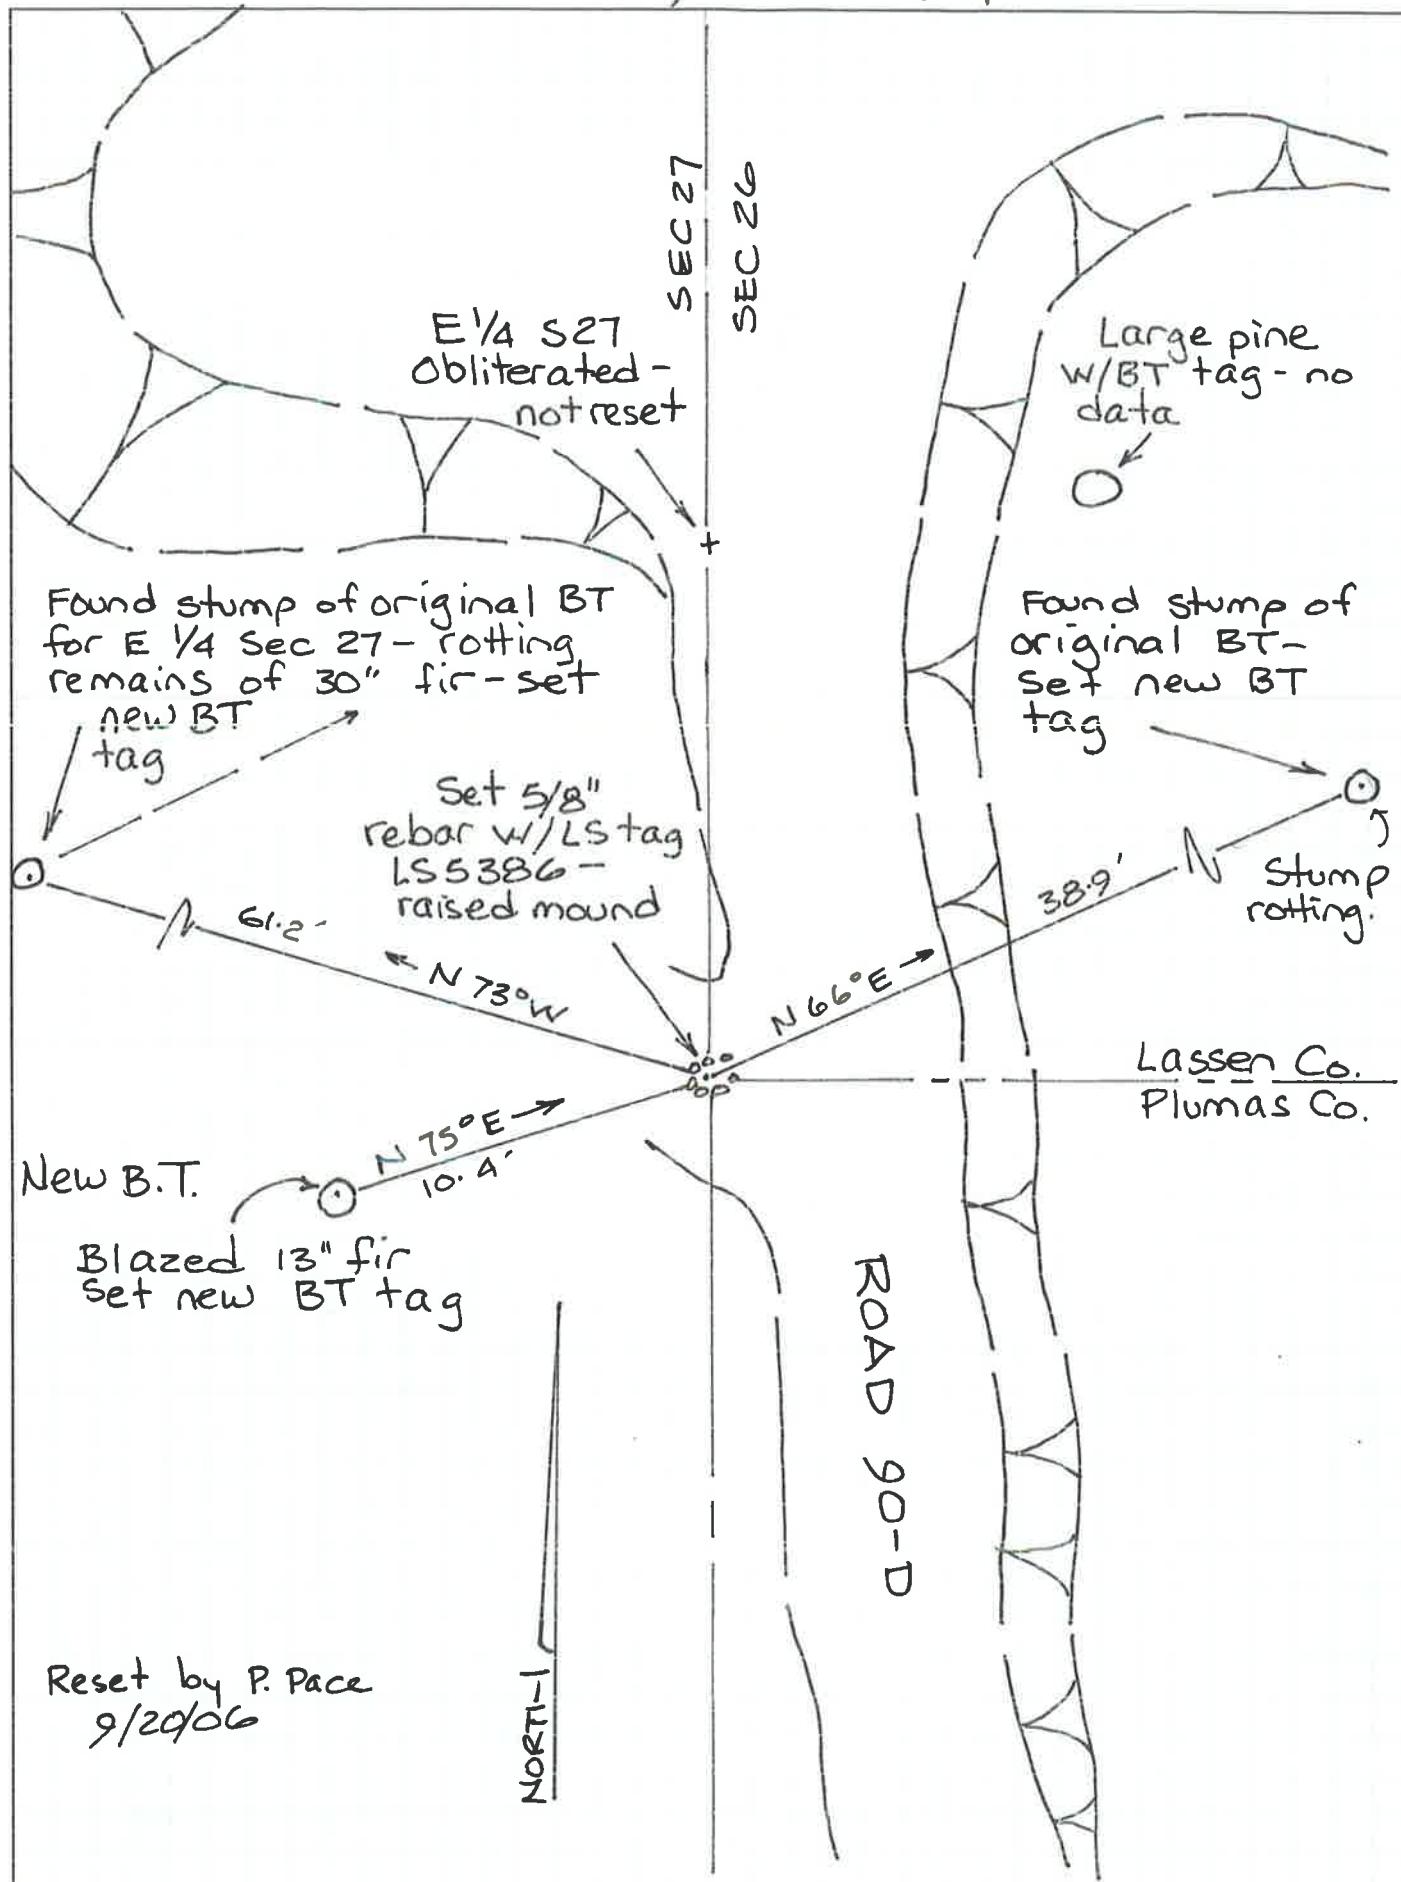
T28N, R8E MDM

Found original Bearing Tree stump in poor condition. No trace of original GLO monument; destroyed by road. Also found original BT for E 1/4 Sec 26. That monument was destroyed by road work as well. The two BT's provided a good check. See sketch and photos.

A description of the physical condition of the monument as found and as set or reset: Reset the W 1/4 of Section 26 with a 5/8" rebar and wired brass LS tag to it - LS 5386. Raised mound, tagged two orig. BT's as shown and created new Bearing Tree.
