CORNER RECORD

Document Number 359

County of Plumas, California

Brief Legal Description Lot 8, 6 RS 112, Grizzly Lake Resort Improvement District

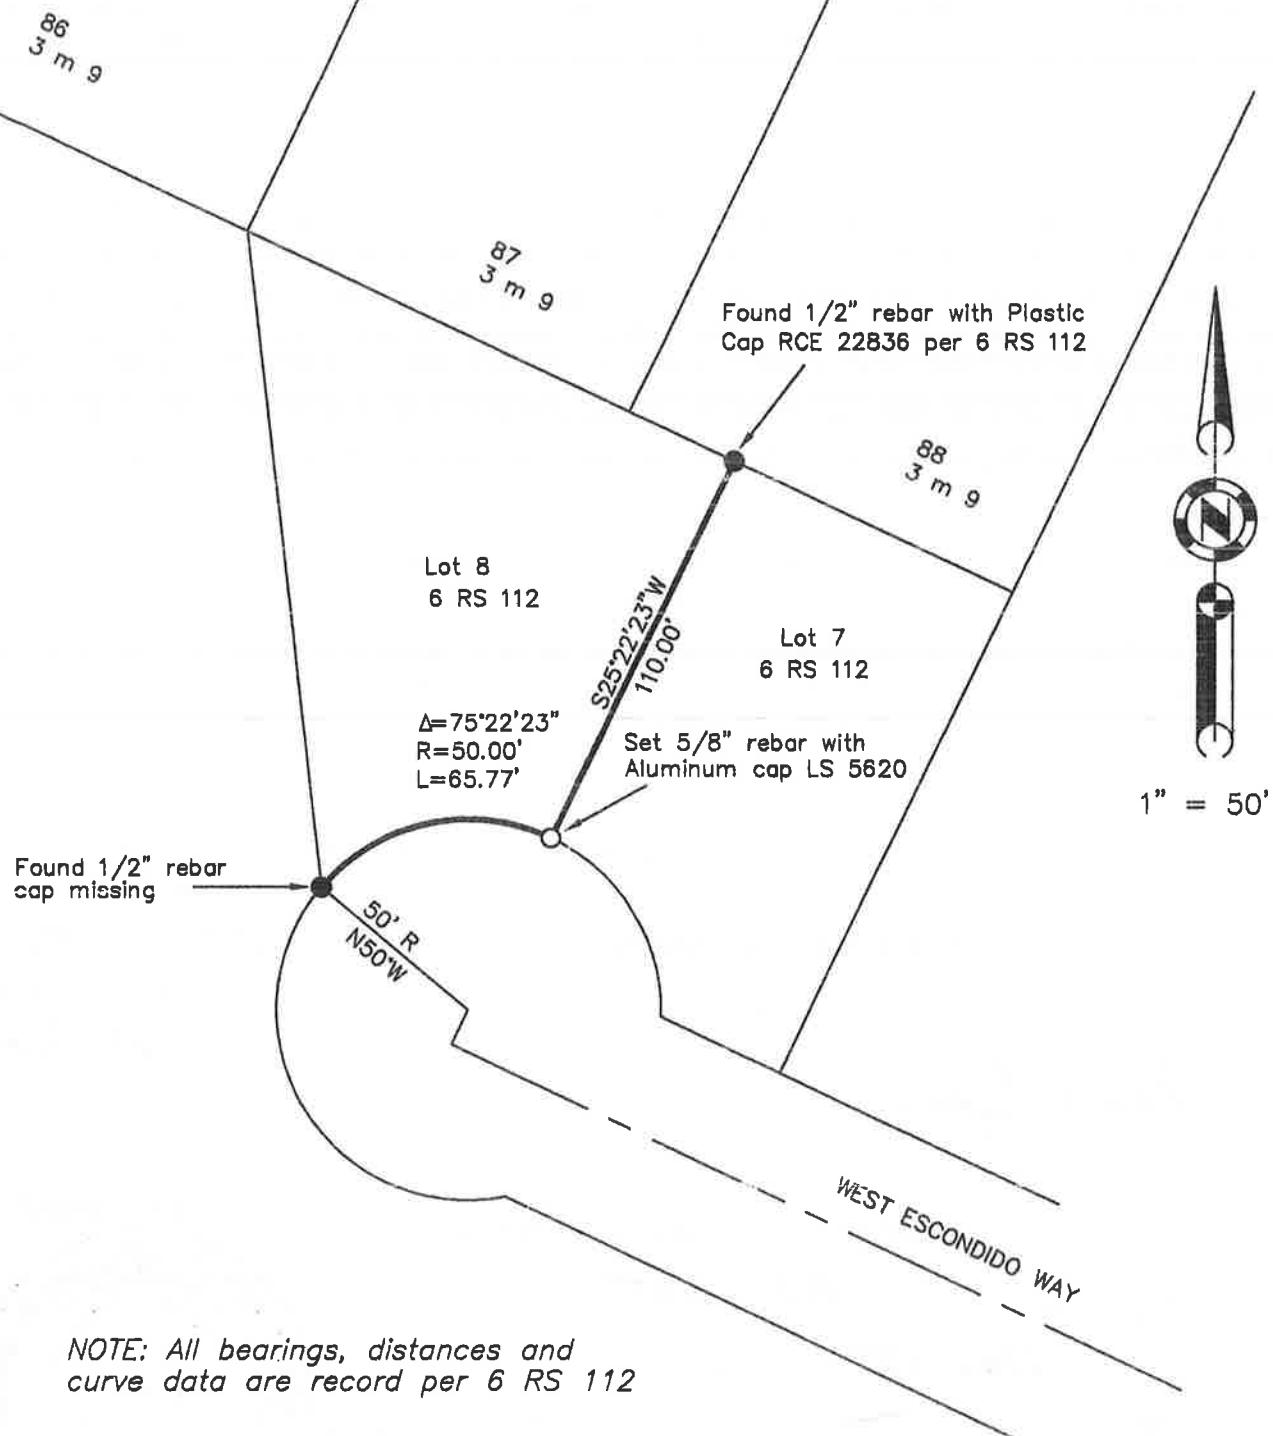
Lot 8, 6 RS 112
 Grizzly Lake Resort
 Improvement District

Southeast corner of Lot 8 missing used Northeast corner and Southwest corner of Lot 8 to set Southeast corner of Lot 8 in record position as shown on attached sketch.A description of the physical condition of the monument as found and as set or reset: Set 5/8" rebar with Aluminum cap stamped LS 5620 as shown on attached sketch.
