CORNER RECORD

Document Number: 377

Lot 143, Lake Almanor West Unit No.1, 4 M 47 Plumas County records

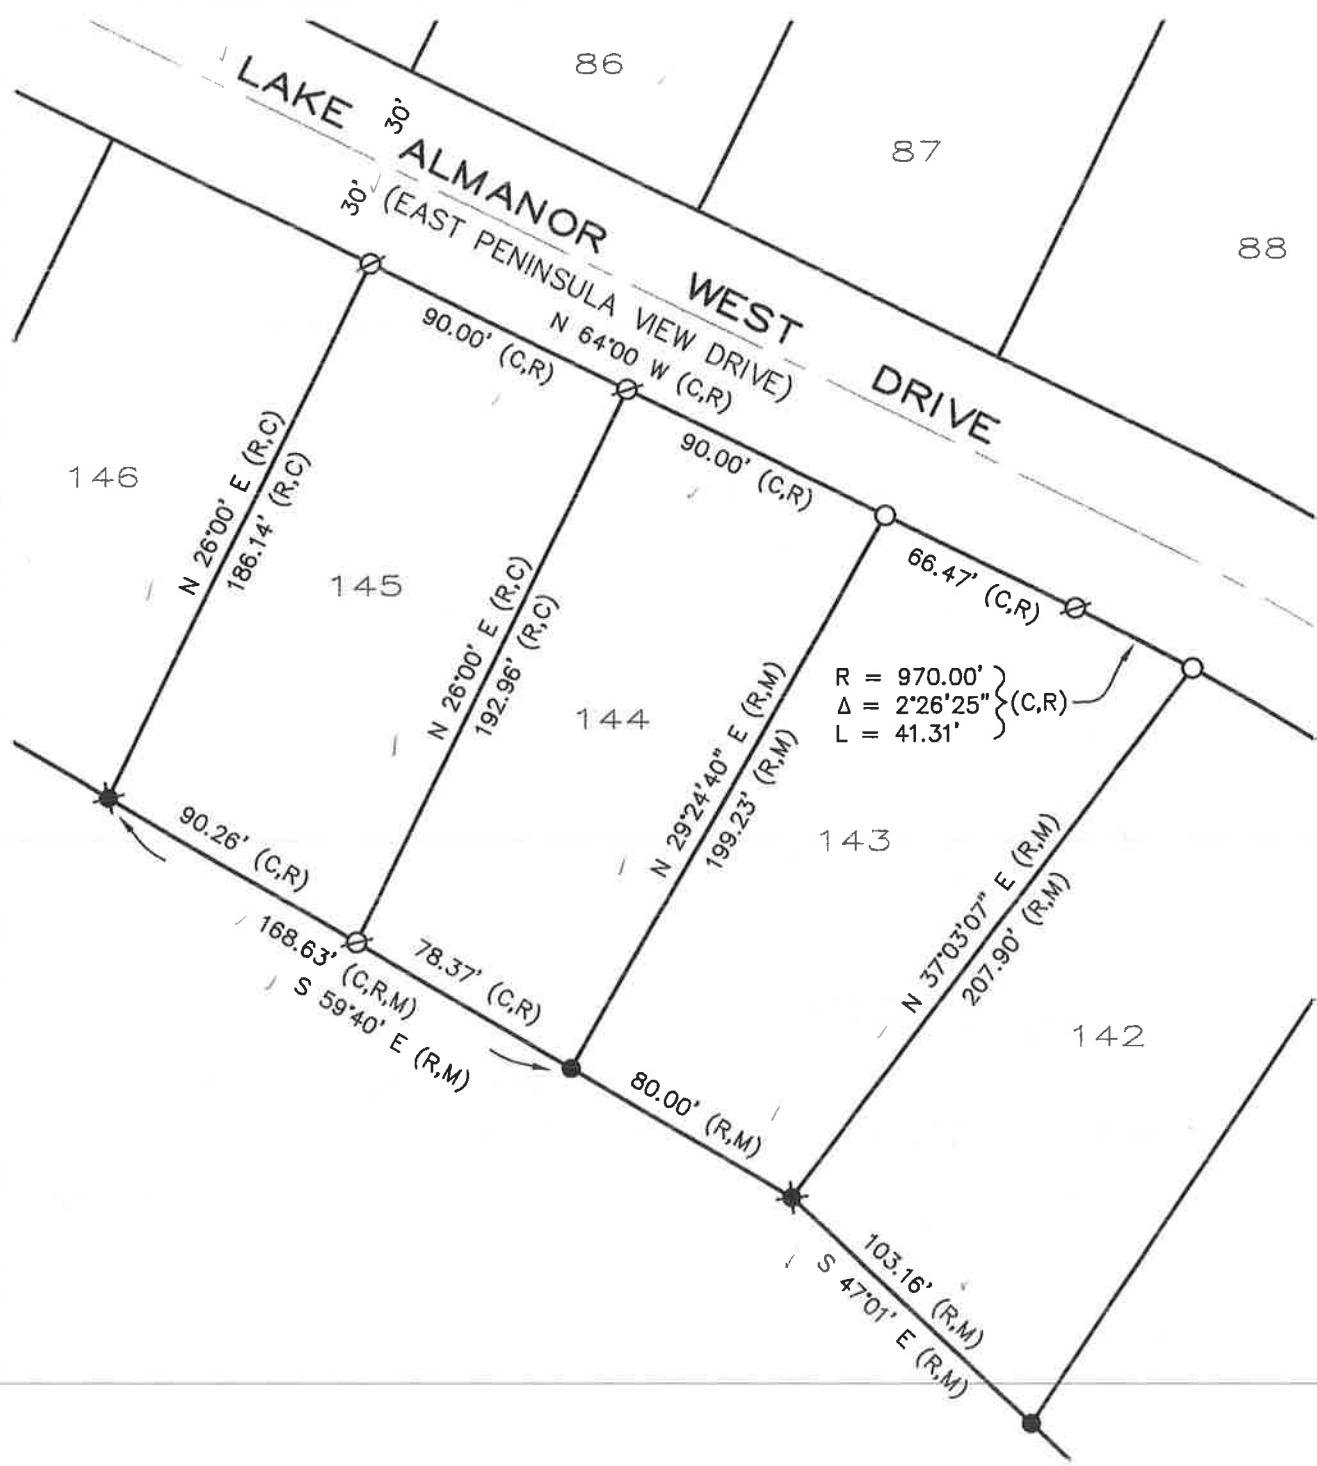
✓ Found 1/2" pipe with brass tag, L.S. 3202, at locations shown on the attached plat.

Set 5/8" rebar with plastic cap at Northerly corners of lot 143 as shown on the attached plat.

SCALE 1"=60'
