## CORNER RECORD

Portion of Section 10, T. 22 N., R. 13 E., M.D.M. County of Plumas, California  
 Brief Legal Description Lot 102, Iron Horse Rancho Subdivision, 3 Maps 110

Date of Survey December 2, 2008

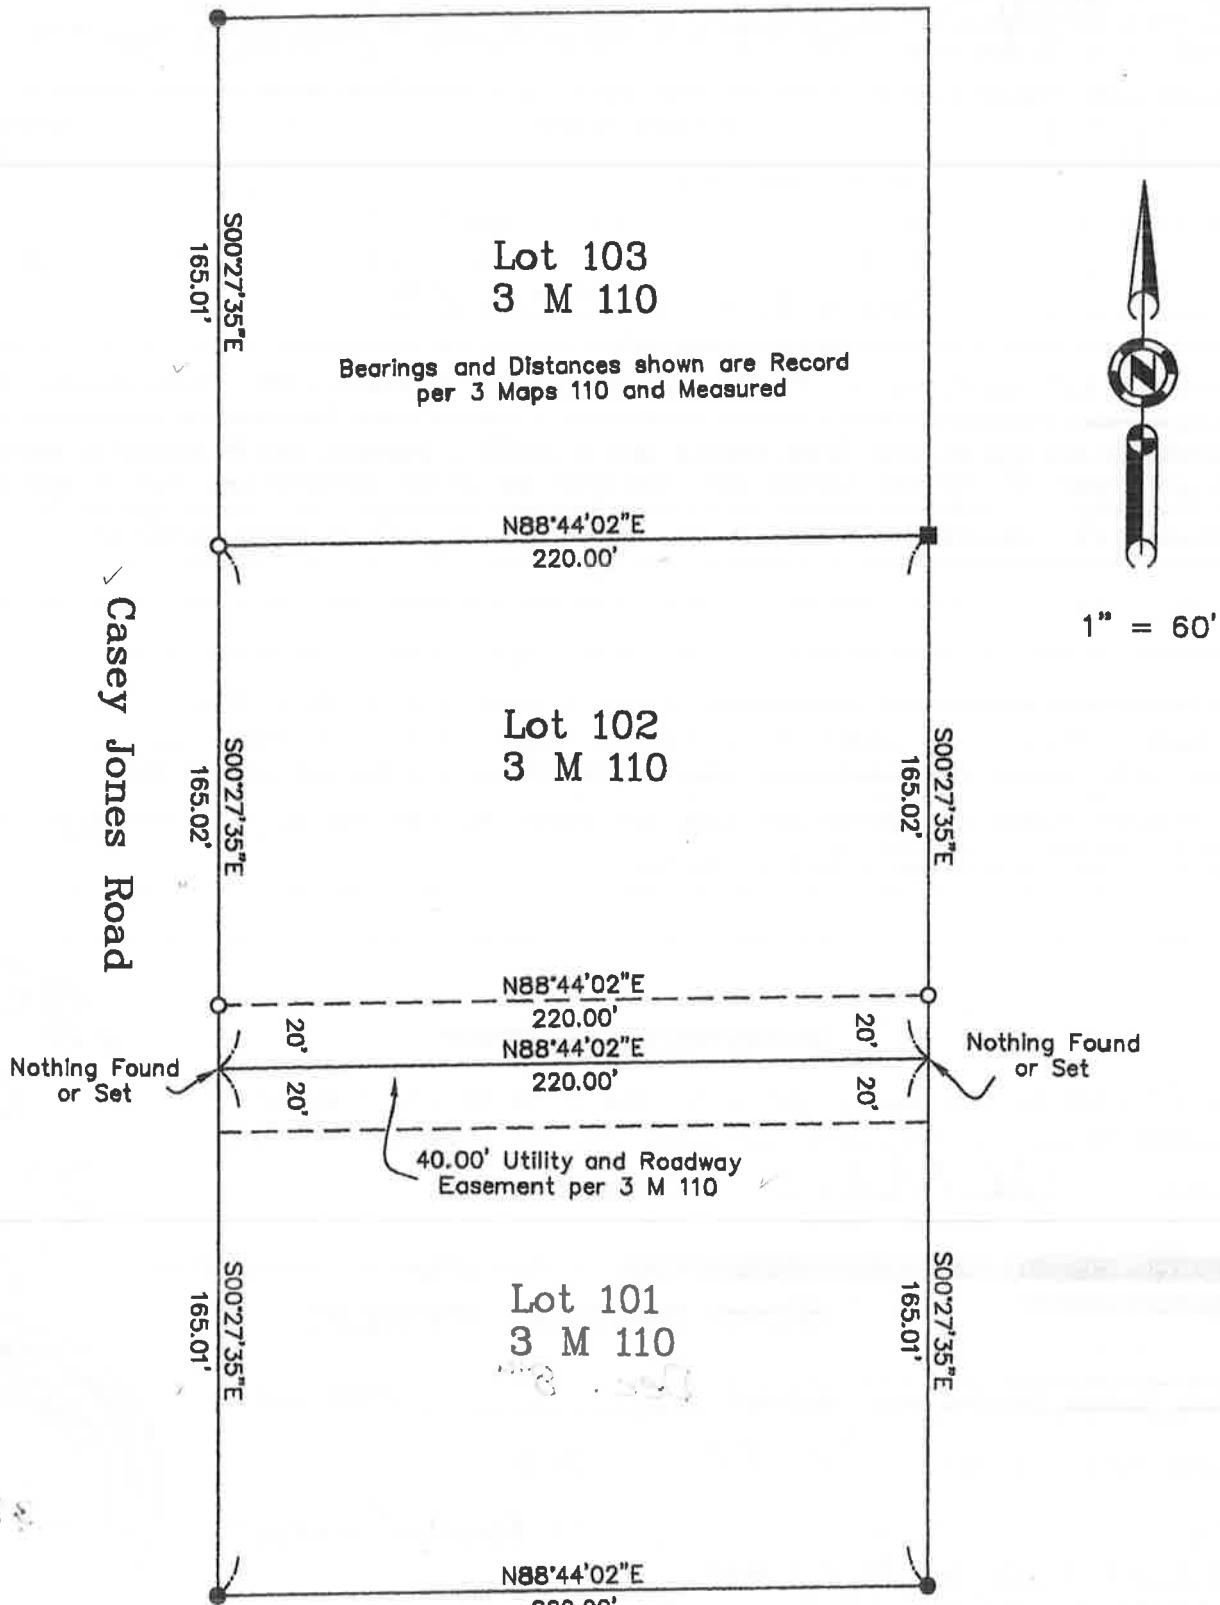
✓ Found 3/4" I.P. at NW corner Lot 103 and SW & SE corners Lot 101 in good condition.  
 ✓ Found 1/2" square head Bolt at NE corner of Lot 102 in good condition.

Set 5/8" Rebar with Aluminum Cap, LS 5620, at NW corner of Lot 102.

Set 5/8" Rebar with Aluminum Cap, LS 5620, marked RW 20 102, on Road Easement line at locations shown on attached sketch.
