CORNER RECORD

City of PORTOLA

Brief Legal Description Centerline of Main Street between First Ave. and Second Ave. 8RS115

SECTION 1
T.22N., R.13E., M.D.M.

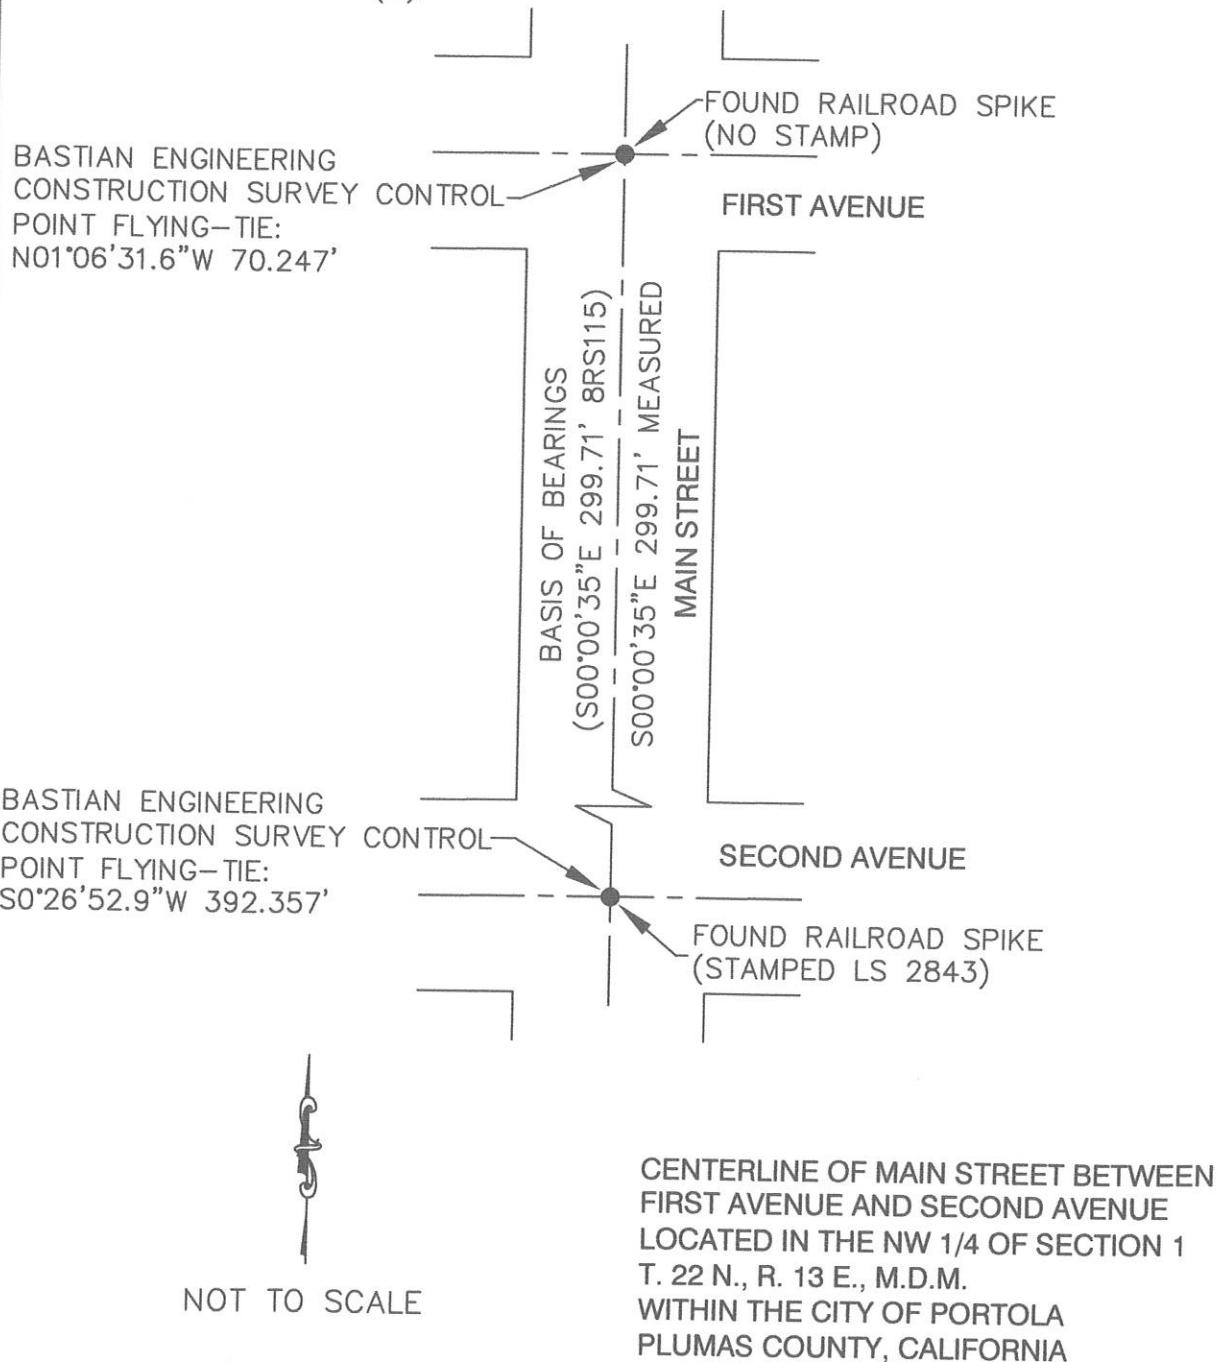
Identification and type of corner found: Evidence used to identify or procedure used to establish or reestablish the corner:
FOUND STREET CENTERLINE MONUMENTS, AS SHOWN ON PAGE 2, IN RECORD POSITION PER
8 RS 115. SURVEY CONTROL POINTS WERE SET TO PROVIDE TIES FOR THE FUTURE
REESTABLISHMENT OF THE MONUMENTS DUE TO ROAD CONSTRUCTION.

FOUND RAILROAD SPIKES AS SHOWN ON 8 RS 115.

- Found corner as described per Book 5 of Records of Survey at Page 115.

1. The bearing and distance shown between the found monuments are record and measured per Book 8 of Records of Survey at Page 115.
2. The purpose of this Corner Record is to reference the location of the monuments shown hereon and to facilitate their reestablishment after they are removed for a Public Works construction project, per LSA Section 8771(b).
